Service Bulletin

File In Section: 08 - Body and Accessories
Bulletin No.: 03-08-06-001
Date: February, 2003

Subject: Bubbles in the Paint Around the Perimeter of the Roof (Replace Roof)

Models: 1999-2002 Chevrolet Camaro
1999-2002 Pontiac Firebird

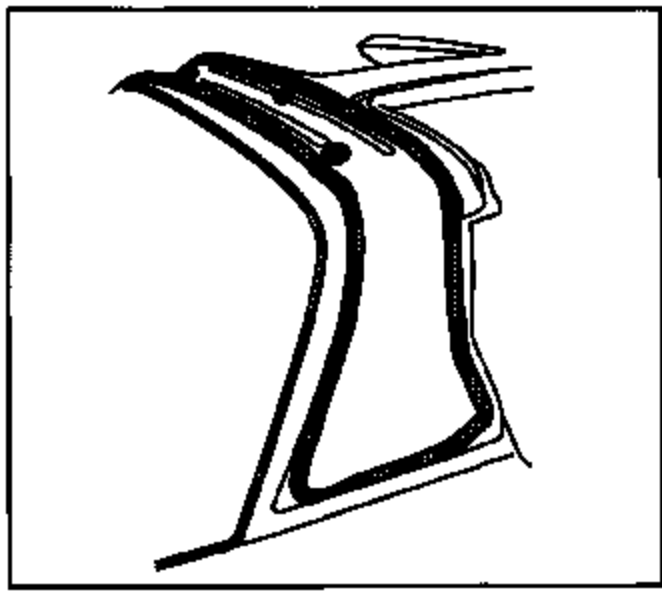
1233108

Some customers may comment that there are bubbles in the paint around the perimeter of the roof.

5. Use the wire method to cut the urethane around the perimeter of the roof. Refer to the above illustration for urethane location.
6. Remove any excess but not all of the urethane from the body.

7. Apply primer 76 mm (3 in) around the perimeter to the roof panel.
8. V cut the urethane tube and apply a 19 mm (3/4 in) high bead around the perimeter of the roof and the three dots across the back.
