Article No.: TASC Tip_11-06

4L60-E flares on 2-3 shift

Now what?

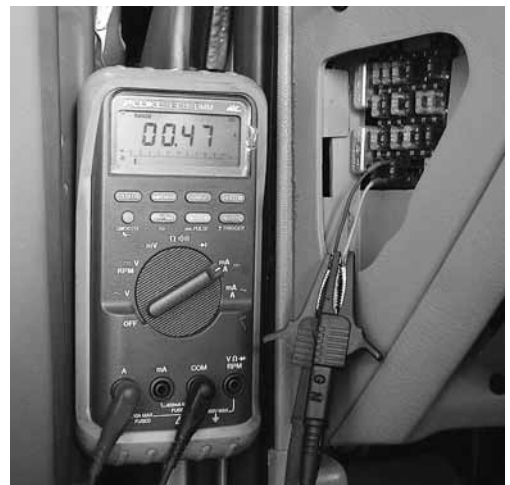
For this vehicle I tapped into the transmission +Positive power supply by replacing the 'Trans' fuse with the two leads of the DVOM. Now, all power for this circuit is flowing through the amp section of the DVOM and the circuit remains protected by the internal fuse in the meter. Figure 1 shows the set-up using a conventional DVOM. With the key on and using a scanner with bi-directional controls, the next step is to command 3rd gear, which turns both "A" and "B" shift solenoids off on a 4L60-E. At this point, zero-out the DVOM so the current draw from any other components sharing this circuit is canceled out and you are monitoring only current changes you command from this point on. Commanding 4th turns only the "A" solenoid on, while commanding 2nd turns only "B" solenoid on.

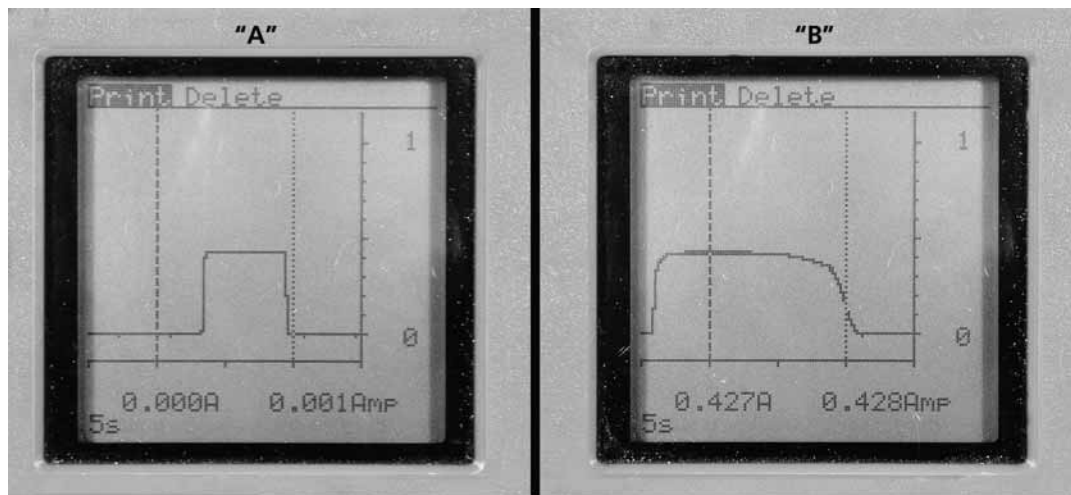
Using this simple DVOM set-up, we watched the current draw change as each solenoid was turned on and off. Although the maximum current draw of the two circuits was almost identical, their behavior was not. When turned off, the "A" solenoid would drop to zero in a fraction of a second, whereas the "B" solenoid would take about 2 seconds to drop to zero. We recorded the behavior using the graphing capability of a Snap-on™ Vantage in order to get a closer look and to show you a picture of what we spotted on the DVOM. Figure 2 shows the difference when the "A" and "B" solenoids were compared. When the computer did not turn

"A" solenoid turns on and off cleanly.

"B" solenoid does not turn off cleanly. Instead, amperage flow takes 2 seconds to gradually drop off.

the "B" solenoid off cleanly, it would not exhaust its oil fast enough and the 2-3 shift valve would move gradually instead of moving crisply from one position to the other. This allowed the 2-4 band to come off momentarily before the 3-4 clutch applied, resulting in a 2-3 flare.

from a decaying capacitor to a silicon chip going bad because someone sneezed in the clean room when it was being made. I have seen two vehicles with this problem locally, so there is a good chance there are more bad computers out there. So, if you run across a 2-3 flare, keep in mind the computer as a possible cause.
