#01-08-58-002: Info - General Windnoise/Water Leak Diagnostic Guide - (Apr 17, 2001)

Subject: General Windnoise/Water Leak Diagnostic Guide

Models: 1998-2001 Chevrolet Camaro
1998-2000 Pontiac Firebird

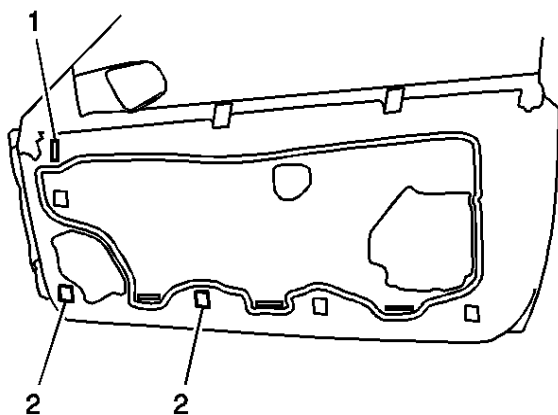
The front or rear floor is wet (convertible, hard top, T-top models).

The small water deflectors may be mispositioned or improperly installed.

- Make sure the rectangular slot is taped over with duct tape. Refer to item 1 in Figure 2.
- Ensure the water deflector seals fully to the door inner panel surface. It may be necessary to make two small 76 mm x 76 mm (3 in x 3 in) water deflectors. Refer to item 2 in Figure 2 and install these to the inside of the door inner panel at the locations indicated. Use a piece of plastic from the shipping protective material for either the door trim panel or the seat assemblies (or similar material)

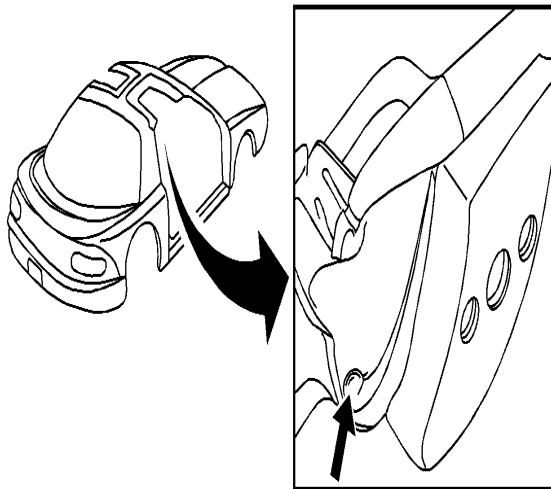
Figure 4

There is water in the rear floor foot well (T-top models).

The upper "B" detail can allow water to stand and fill the lower weatherstrip. This can be too much water for the drain holes to accommodate. The upper "B" drain must be clear of debris. With the door open and using a squeeze bottle to fill the weatherstrip with water, the water should flow from the bottom drain holes. Refer to Figure 4. If too much water is entering the rear "B" detail, the T-top may not be sealing against the rear sealing strip. If the rear is sealed properly and there is still too much water entering the drain, enlarging the drain holes at the bottom of the weatherstrip will help. **DO NOT PUNCH A DRAIN HOLE IN THE SIDE OF THE WEATHERSTRIP AS THIS WILL PROVIDE A PATH FOR WINDNOISE.**

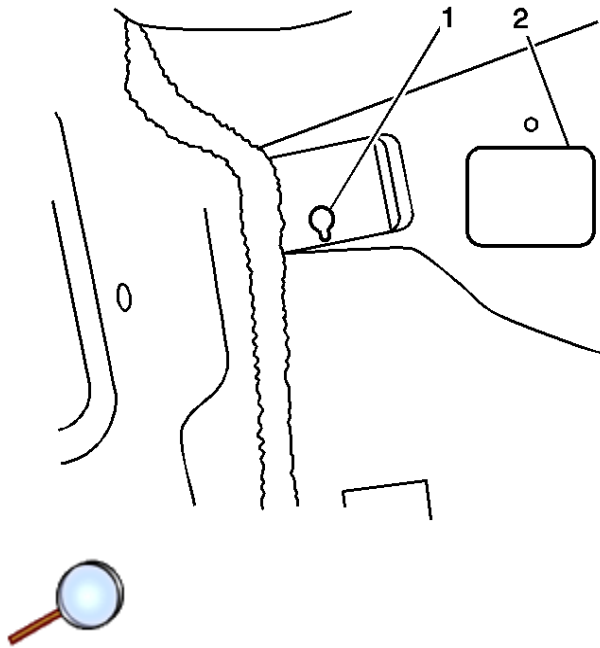
Figure 5

The driver's floor is wet (convertible, hard top, T-top models).

1. The hood release cable may not be sealed at the front of dash. Refer to item 1 in Figure 5.
2. The body harness grommet may not be sealed. Refer to item 2 in Figure 5.

Make sure both are SEATED properly. if necessary, seal with GM Weatherstrip Adhesive, P/N 12345097 (in Canada, use P/N 10953479).

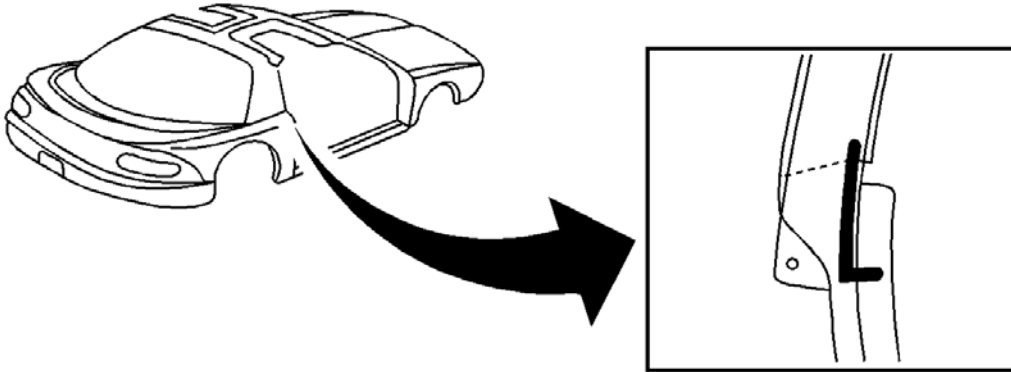
The molded weatherstrip detail at the base of the lock pillar may not be sealed properly causing windnoise and/or water leaks (hard top, T-top models).

The material sealing the weatherstrip detail to the body surface between the lock pillar retainer and the mounting flange on the quarter panel may be mispositioned or missing.

Apply a new seal using GM Silicone Sealant, P/N 12345739 (in Canada, use P/N 10953541), as shown in Figure 9 (apply in a straight line from the inner edge of the lock pillar retainer to the base of the mounting tab and then 90 degrees inboard to the lock pillar flange) and reinstall the weatherstrip to the flange and the retainer.

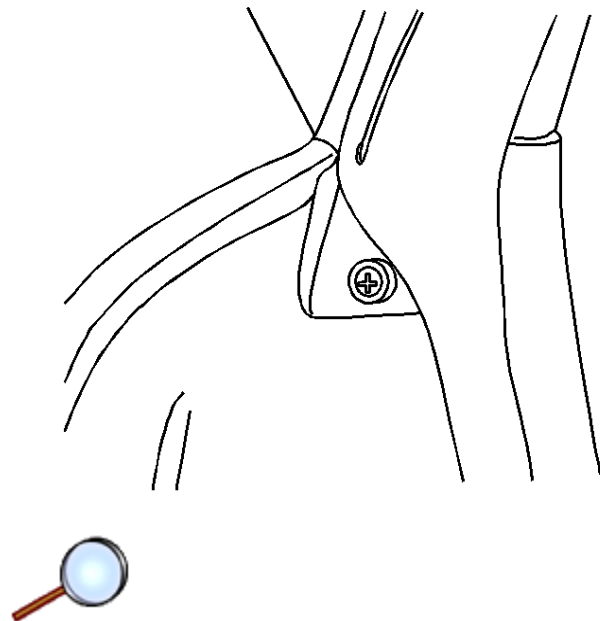
Figure 11

There is windnoise and/or water leaks in the rear of the vehicle (convertible, hard top, T-top).

The weatherstrip in the area indicated shows where the weatherstrip relaxes and loses contact with the door glass. This generates windnoise. Refer to Figure 11.

Loosen the "B" pillar weatherstrip retaining screw and tighten the screw while holding the weatherstrip.
