GM bulletins are intended for use by professional technicians, NOT a "do-it-yourselfer". They are written to inform these technicians of conditions that may occur on some vehicles, or to provide information that could assist in the proper service of a vehicle. Properly trained technicians have the equipment, tools, safety instructions, and know-how to do a job properly and safely. If a condition is described, DO NOT assume that the bulletin applies to your vehicle, or that your vehicle will have that condition. See your GM dealer for information on whether your vehicle may benefit from the information.

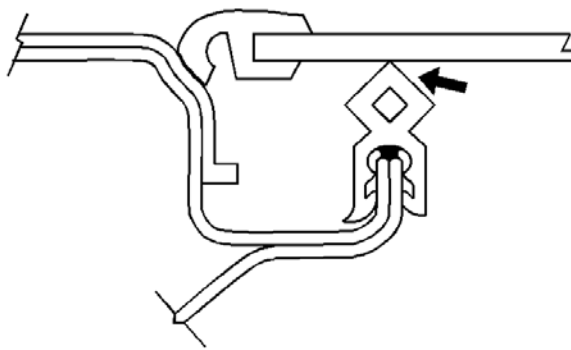
Figure 18

There is windnoise from the T-top.

The T-top may not be seated against the roof seal. A business card should not be able to easily slip between the T-top and the seal.

Remove the shim under the striker.

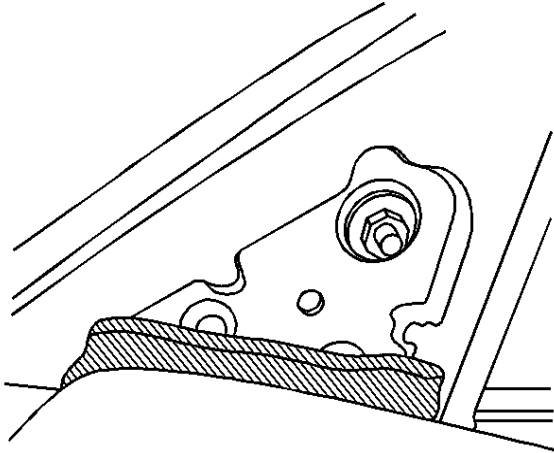
Figure 22

There is road noise or windnoise around the mirror patch (convertible, hard top, T-top models).

The foam blocker may not be in place.

Remove the foam blocker and split the difference between the upper and the lower part of the trim pad. Refer to Figure 22.

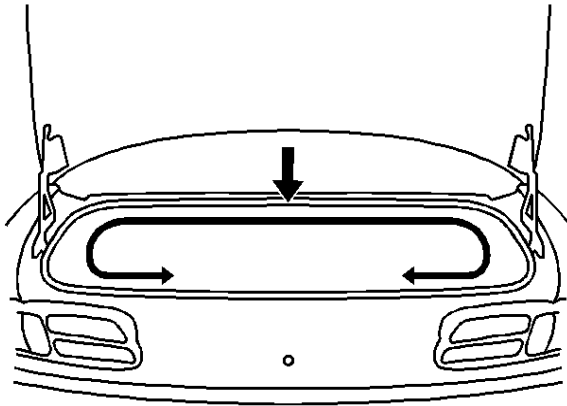
Figure 25

There is a water leak in the rear compartment (convertible models).

The rear compartment primary seal may not be seated properly.

Center the weatherstrip in the opening and install the weatherstrip. Make sure the seal is fully seated to the hem flange. Refer to Figure 25.

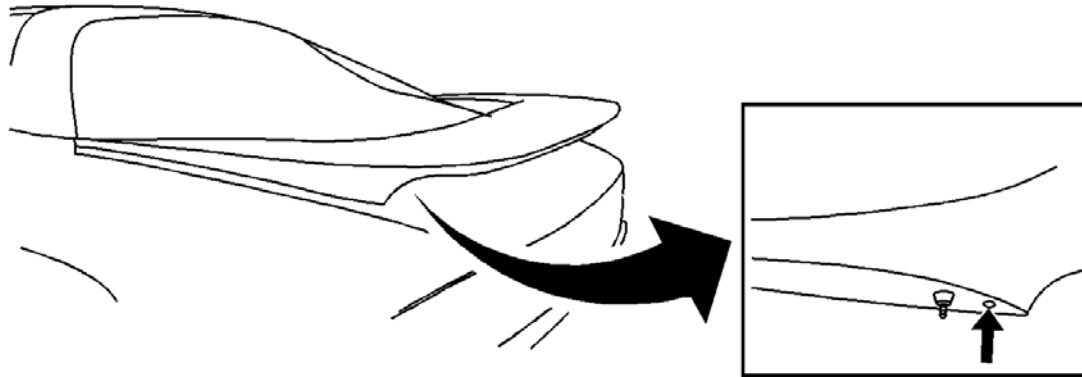
Figure 28

Water drips from the left hand side strut attachment on the deck lid (hard top, T-top models).

A plug may be missing from under the left side spoiler. Refer to Figure 28.

Remove the spoiler and install plug, P/N 10231979.
