#01-08-58-002: Info - General Windnoise/Water Leak Diagnostic Guide - (Apr 17, 2001)

Subject: General Windnoise/Water Leak Diagnostic Guide

Models: 1998-2001 Chevrolet Camaro
1998-2000 Pontiac Firebird

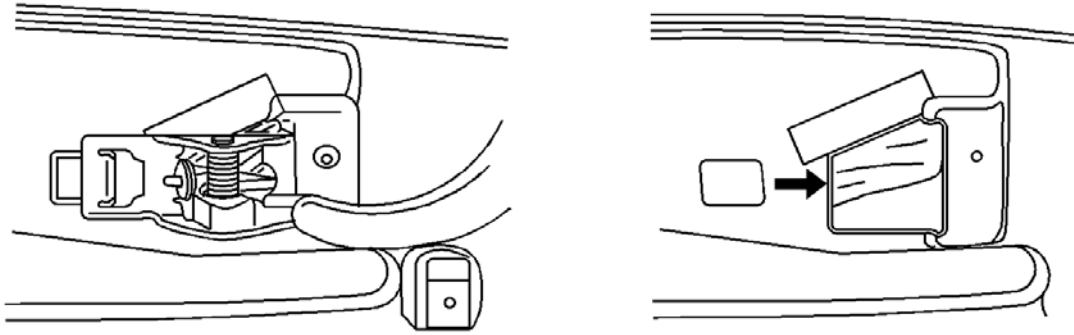
Figure 1

Water drips from the door lock knob or the front floor carpet is wet (convertible, hard top, T-top models).

The water deflector may not be seated properly behind the door handle.

Seat the water deflector behind the door handle so that the bottom of the water deflector is inboard of the door. Refer to Figure 1.

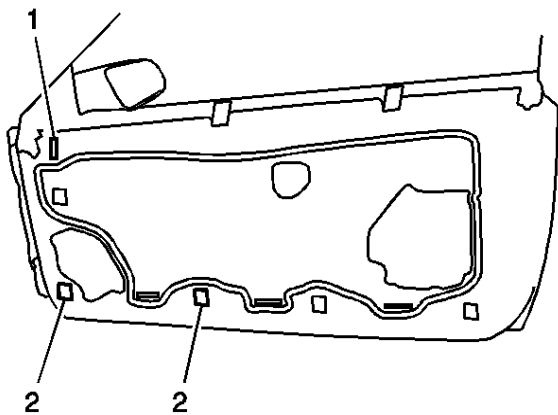
The front or rear floor is wet (convertible, hard top, T-top models).

The small water deflectors may be mispositioned or improperly installed.

- Make sure the rectangular slot is taped over with duct tape. Refer to item 1 in Figure 2.
- Ensure the water deflector seals fully to the door inner panel surface. It may be necessary to make two small 76 mm x 76 mm (3 in x 3 in) water deflectors. Refer to item 2 in Figure 2 and install these to the inside of the door inner panel at the locations indicated. Use a piece of plastic from the shipping protective material for either the door trim panel or the seat assemblies (or similar material)

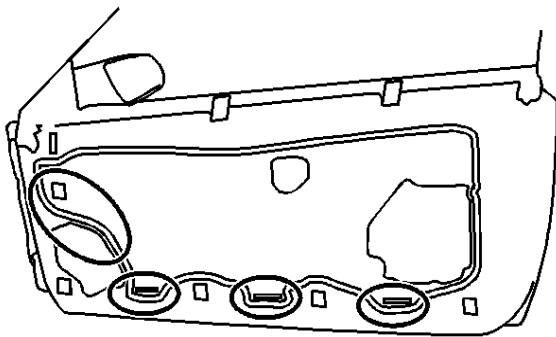
Figure 3

The front or rear floor is wet (convertible, hard top, T-top models).

The water deflector may not be seated properly to the door surface.

Seat the water deflector to the door surface at the primary locations. Refer to Figure 3. If the adhesive surface is dirty and the water deflector needs to be replaced, follow the service procedure listed below.

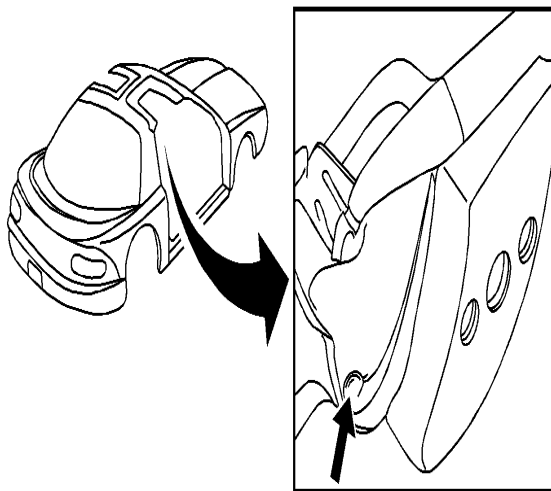
Figure 4

There is water in the rear floor foot well (T-top models).

The upper "B" detail can allow water to stand and fill the lower weatherstrip. This can be too much water for the drain holes to accommodate. The upper "B" drain must be clear of debris. With the door open and using a squeeze bottle to fill the weatherstrip with water, the water should flow from the bottom drain holes. Refer to Figure 4. If too much water is entering the rear "B" detail, the T-top may not be sealing against the rear sealing strip. If the rear is sealed properly and there is still too much water entering the drain, enlarging the drain holes at the bottom of the weatherstrip will help. **DO NOT PUNCH A DRAIN HOLE IN THE SIDE OF THE WEATHERSTRIP AS THIS WILL PROVIDE A PATH FOR WINDNOISE.**

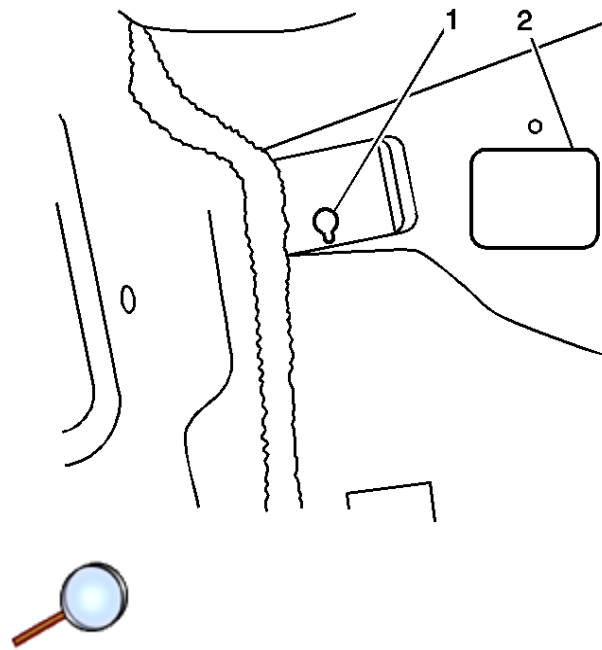
Figure 5

The driver's floor is wet (convertible, hard top, T-top models).

1. The hood release cable may not be sealed at the front of dash. Refer to item 1 in Figure 5.
2. The body harness grommet may not be sealed. Refer to item 2 in Figure 5.

Make sure both are SEATED properly. if necessary, seal with GM Weatherstrip Adhesive, P/N 12345097 (in Canada, use P/N 10953479).

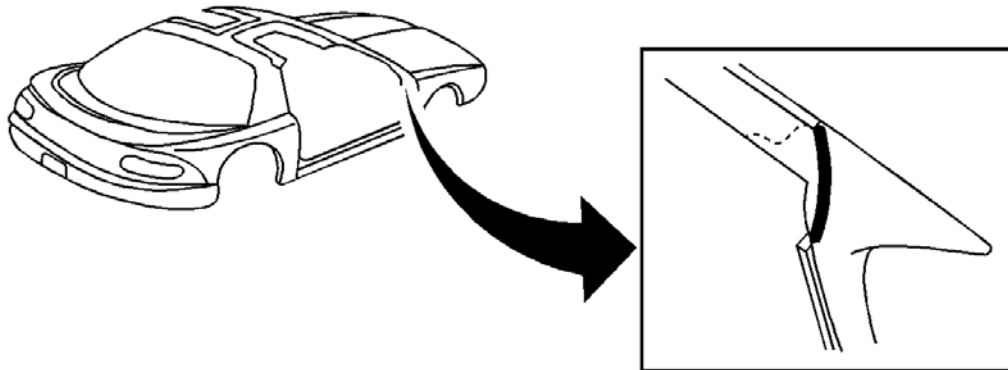
The molded weatherstrip detail at the base of the windshield may not be properly sealed causing the front floor to be wet (hard top, T-top models).

The material sealing the weatherstrip detail to the body surface between the pillar retainer and the mounting flange on the hinge pillar may be mispositioned or missing.

Apply a new seal using GM Silicone Sealant, P/N 12345739 (in Canada, use P/N 10953541), as shown in Figure 6 (almost a straight line from the outer edge of the pillar retainer to the inner hinge pillar flange should be used) and reinstall the weatherstrip to the flange retainer.

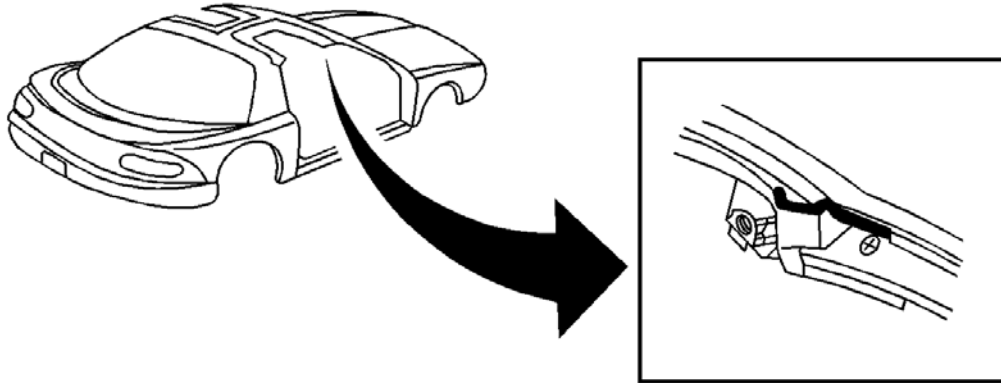
Figure 7

The front roof gutter molded weatherstrip detail to the roof sheet metal may not be sealed properly (T-top models). Water entering this area usually runs down the "A" pillar and ends up on the carpet below the instrument panel.

- The weatherstrip molded detail may not be sealed to the sheet metal gutter.
- Small holes or tears may exist in the molded detail at the attaching insert.

- Apply a new seal using GM Silicone Sealant, P/N 12345739 (in Canada, use P/N 10953541), to the end of the roof gutter, under the molded weatherstrip detail, as shown in Figure 7.
- Apply an even amount of GM P/N 12345097 (in Canada, use P/N 10953479) or 3M P/N 08011, or the equivalent, to the hole or tear for sealing.

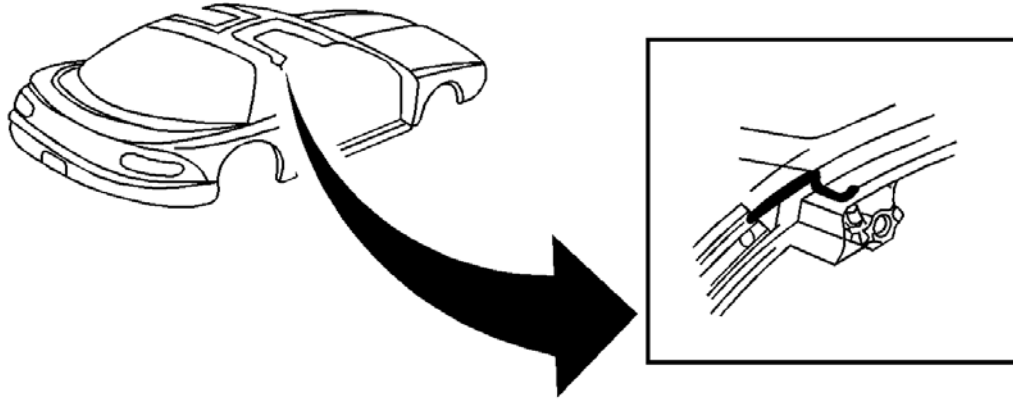
Figure 8

The rear roof gutter molded weatherstrip detail to the roof sheet metal may not be sealed properly causing water leaks (T-top models).

- The weatherstrip molded detail may not be sealed to the sheet metal gutter.
- Small holes or tears may exist in the molded detail at the attaching insert.

1. Apply GM Silicone Sealant, P/N 12345739 (in Canada, use P/N 10953541), to the end of the roof gutter, under the molded weatherstrip detail, as shown in Figure 8.
2. Apply an even amount of GM P/N 12345097 (in Canada, use P/N 10953479) or 3M P/N 08011, or the equivalent, to the hole or tear for sealing.

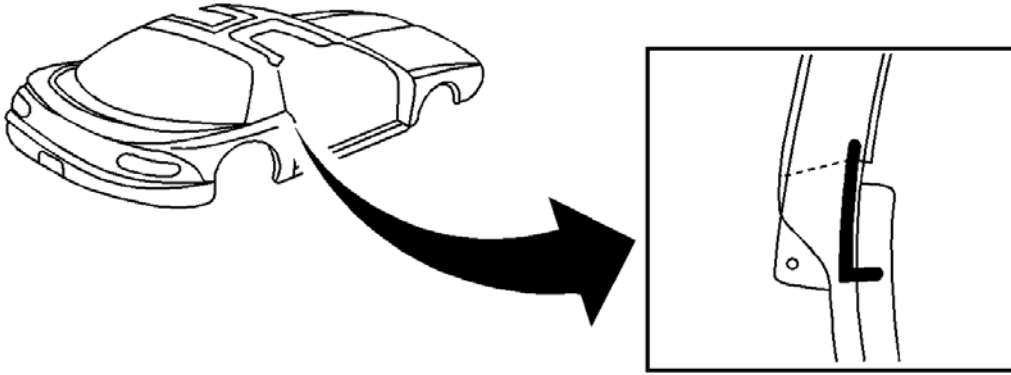
The molded weatherstrip detail at the base of the lock pillar may not be sealed properly causing windnoise and/or water leaks (hard top, T-top models).

The material sealing the weatherstrip detail to the body surface between the lock pillar retainer and the mounting flange on the quarter panel may be mispositioned or missing.

Apply a new seal using GM Silicone Sealant, P/N 12345739 (in Canada, use P/N 10953541), as shown in Figure 9 (apply in a straight line from the inner edge of the lock pillar retainer to the base of the mounting tab and then 90 degrees inboard to the lock pillar flange) and reinstall the weatherstrip to the flange and the retainer.

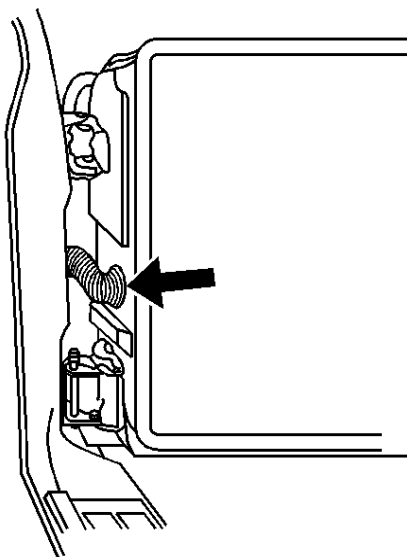
Figure 10

Water leaks through the front floor and/or windnoise through the door.

The door wiring harness rubber grommet may not be seated properly. Refer to Figure 10.

Make sure the grommet lip is seated properly to the door and the "A" pillar.

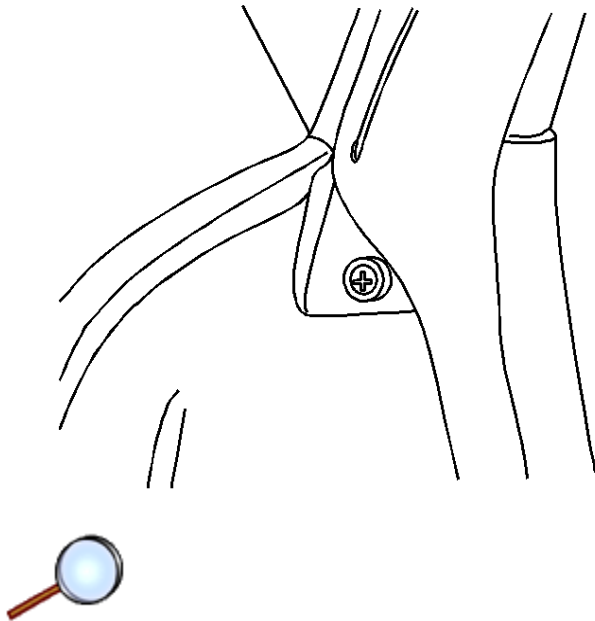
Figure 11

There is windnoise and/or water leaks in the rear of the vehicle (convertible, hard top, T-top).

The weatherstrip in the area indicated shows where the weatherstrip relaxes and loses contact with the door glass. This generates windnoise. Refer to Figure 11.

Loosen the "B" pillar weatherstrip retaining screw and tighten the screw while holding the weatherstrip.

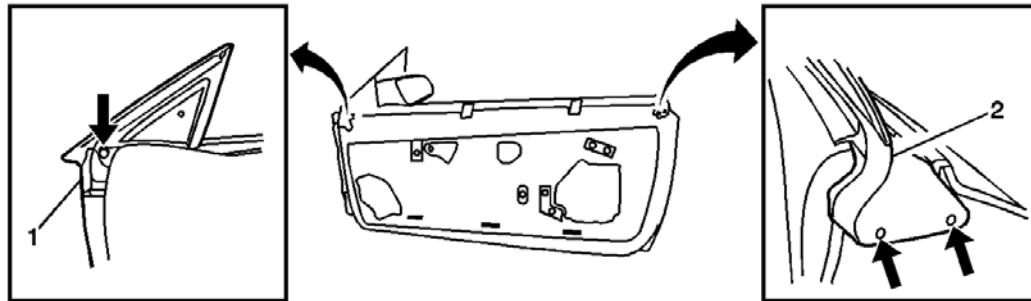
Figure 12

There is windnoise and/or water leaks in the front or rear at the door belt line (convertible, hard top, T-top models).

- Insert the push-in retainers. Refer to Figure 12.
- Ensure that the muket has no folds. Refer to item 1 in Figure 12.
- Ensure that the muket is in contact with the side door glass when the door is closed. Refer to item 2 in Figure 12.

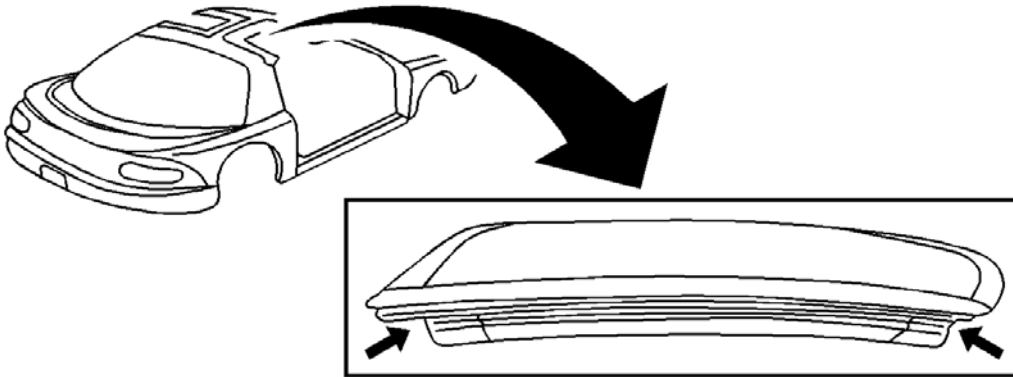
There is windnoise and/or water leaks at the T-top butt joints.

- The butt joint surfaces between the panel and the body details may have improper contact.
- The door glass may not be adjusted properly for height or "tip in" contact.

- The T-top rail weatherstrip is movable in the retainer and should be adjusted to only slight interference on the front and rear edges. The pressure of the closed glass will increase pressure on the joint once the glass is closed. Too much interference will cause the butt joint to pucker and provide a water path. Refer to Figure 13.
- Adjust the door glass to obtain sealing in the butt joints. Refer to General Information on Door Glass Adjustments later in this bulletin.

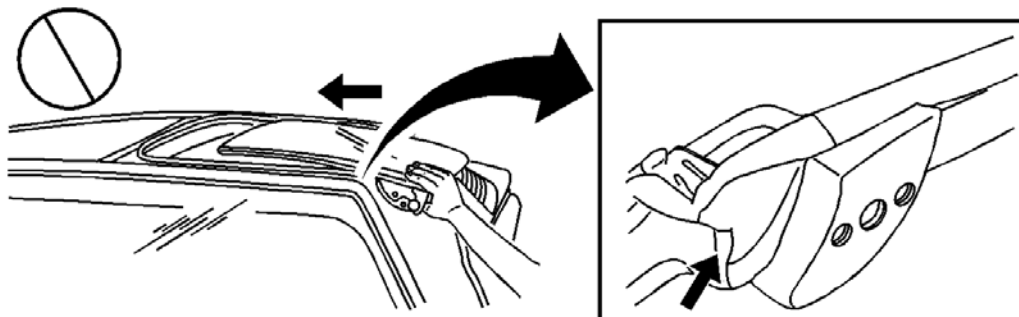
There is windnoise and/or water leaks from the front or rear "butt" joints (T-top models).

The T-top may have been installed improperly. Refer to Figure 14

Make sure the customer is informed on the proper installation. Do not attempt to install the panels by sliding them horizontally toward the center roof rail. Doing so may cause the weatherstrip outer lip to fold under the removable top weatherstrip and may result in leaks and possible damage to the weatherstrip. Refer to Figure 14.

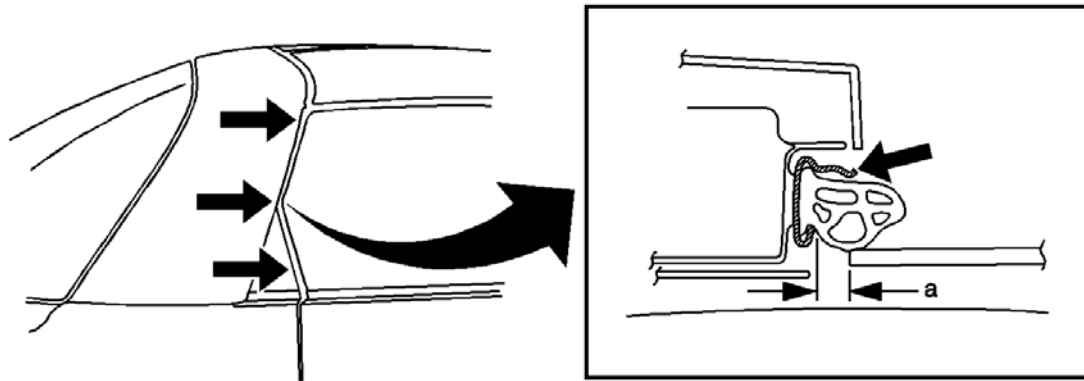
Figure 16

There is windnoise at the rear of the door glass (convertible, hard top, T-top models).

The door glass may not be adjusted forward/rearward for proper contact or you cannot obtain enough glass contact to the weatherstrip at the rear of the door glass.

- Adjust the door glass forward or rearward to obtain a standard dimension of no more than 12 mm (1/2 in) from the edge of the glass to the retainer surface. Refer to measurement A in Figure 16.
- If you cannot obtain enough contact at the rear of the door glass after glass adjustments, adjust the weatherstrip retainer outboard for more contact.
