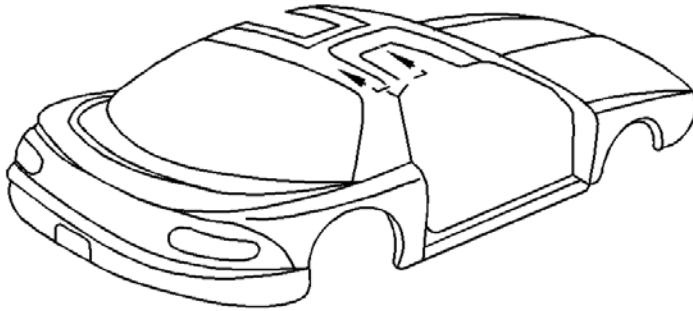
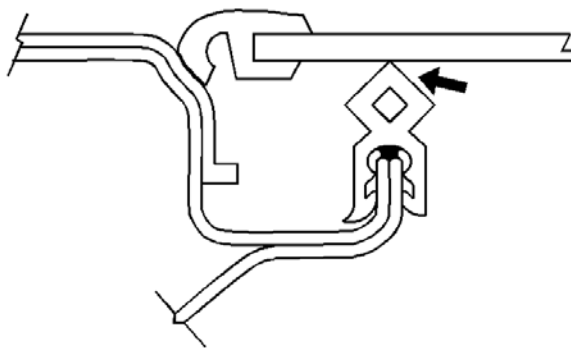
### **Figure 18**

There is windnoise from the T-top.

The T-top may not be seated against the roof seal. A business card should not be able to easily slip between the T-top and the seal.

Remove the shim under the striker.

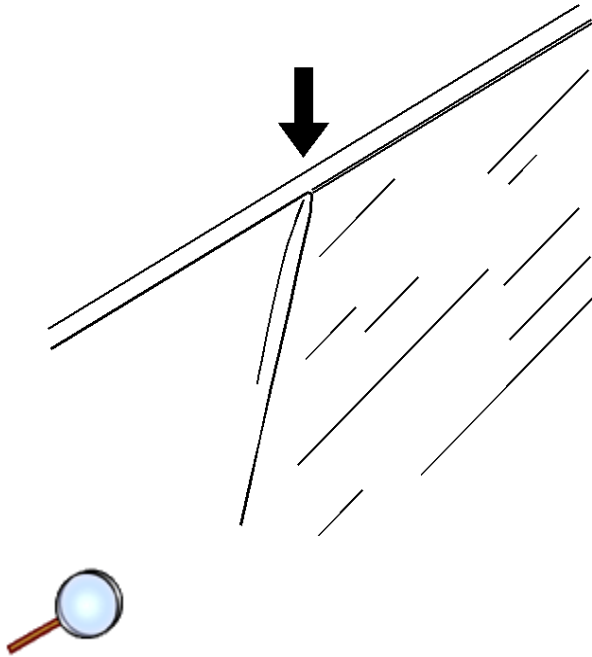
### **Figure 19**

There is windnoise around the mirror patch (convertible, hard top, T-top models).

The door glass or the mirror patch may need adjustment. Refer to Figures 19, 20 and 21.

Align the mirror patch applique with the door open and the window up. The applique should be perfectly in line with the window or it should have a slight "bump" in the seal at the top of the mirror patch applique. Refer to Figure 19 for location.

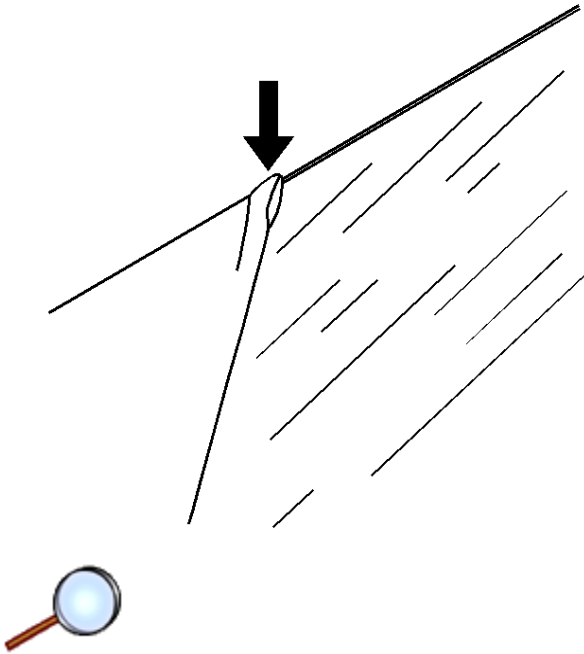
## Figure 21

If the glass is not adjusted properly for height at the arrow, it will cause a bulge in the seal and create a windnoise. Refer to Figure 21.

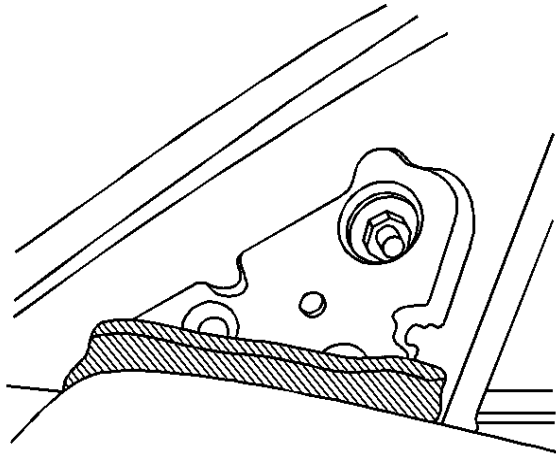
## Figure 22

There is road noise or windnoise around the mirror patch (convertible, hard top, T-top models).

The foam blocker may not be in place.

Remove the foam blocker and split the difference between the upper and the lower part of the trim pad. Refer to Figure 22.

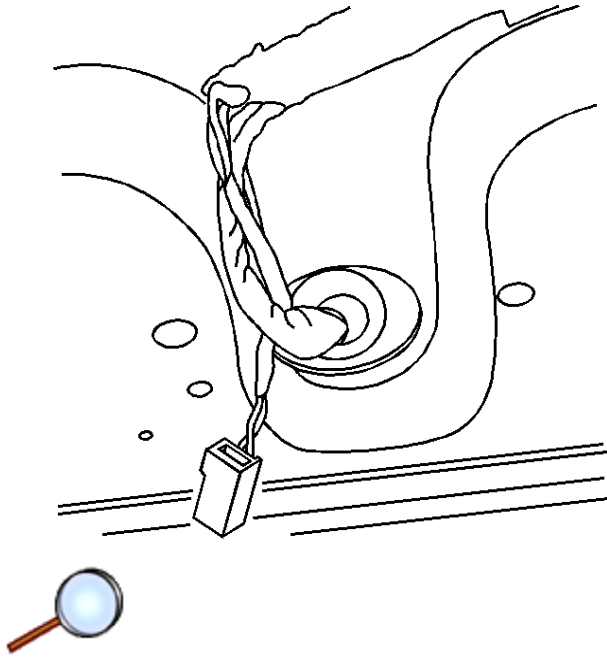
### **Figure 23**

There is a water leak in the rear compartment.

The taillamp harness grommet may not be seated properly.

Make sure that the grommet lip is seated properly. Refer to Figure 23.

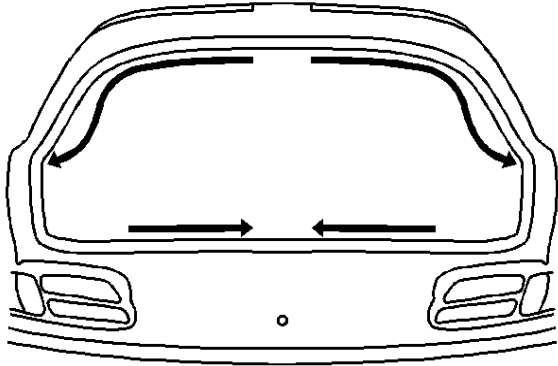
### **Figure 24**

There is a water leak in the rear compartment (hard top, T-top models).

The rear compartment primary seal may not be seated properly.

Center the weatherstrip in the opening and install the weatherstrip. Make sure the seal is fully seated to the hem flange. Refer to Figure 24.

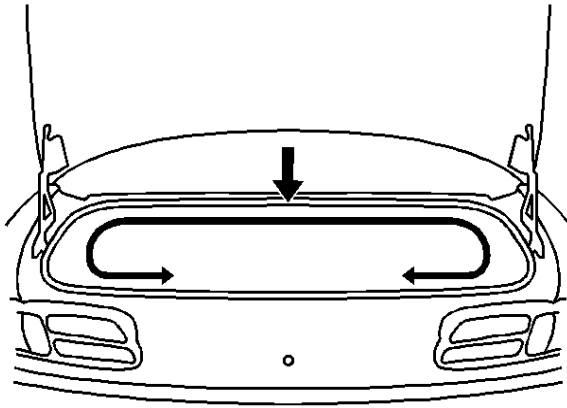
### **Figure 25**

There is a water leak in the rear compartment (convertible models).

The rear compartment primary seal may not be seated properly.

Center the weatherstrip in the opening and install the weatherstrip. Make sure the seal is fully seated to the hem flange. Refer to Figure 25.

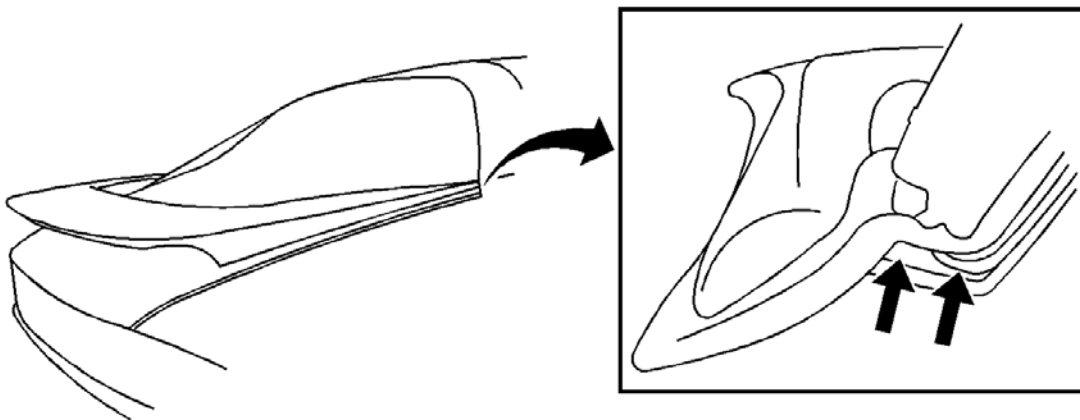
**Figure 26**

There is a water leak in the rear hatch (hard top, T-top models). Some customers may comment that when the rear hatch is opened, water runs out of one or both front lower corners. Refer to Figure 26.

Sealing operations may have been missed at the two locations during assembly.

- The sealer may be missing at both of the lower front corners.
- The sealer may be missing downward from the hinges.

- Determine which area needs to be sealed. Refer to Figures 26 and 27.
- Clean the surface to be sealed using one of the following, or an equivalent:
  - 3M® General Purpose Adhesive Cleaner, P/N 08984
  - Dominion Sure Seal, Sure Solve Stock BSS
  - Kent Acrosol™
- Seal the flange(s) using one of the following, or an equivalent:
  - 3M® Ultropro™ Autobody Sealant
  - Kent High Tech Seam Sealer Clear 10200
  - Dominion Sure Seal Heavy Duty Drip Check LSC Item #9019

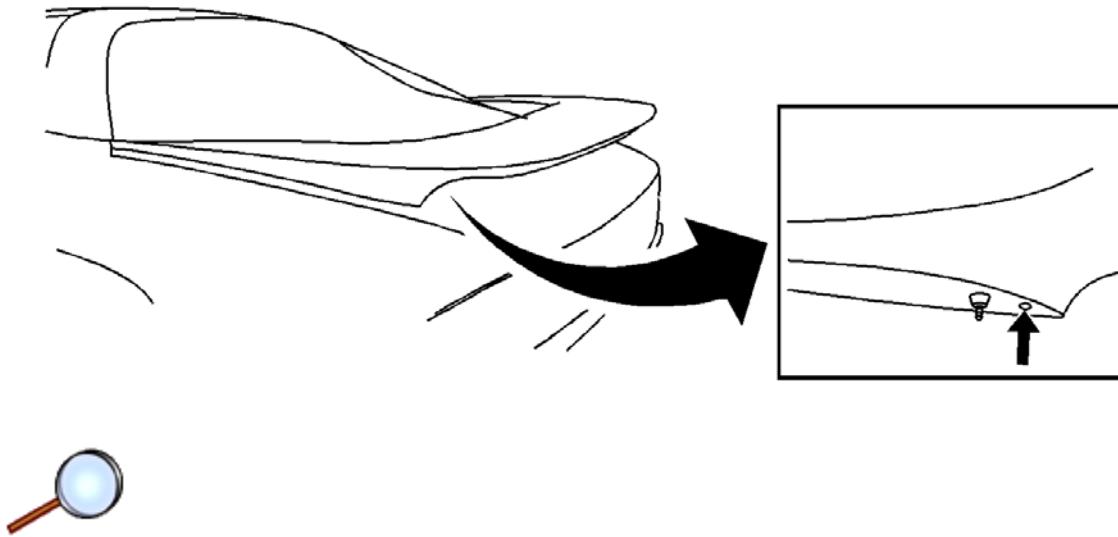
**Figure 28**

Water drips from the left hand side strut attachment on the deck lid (hard top, T-top models).

A plug may be missing from under the left side spoiler. Refer to Figure 28.

Remove the spoiler and install plug, P/N 10231979.

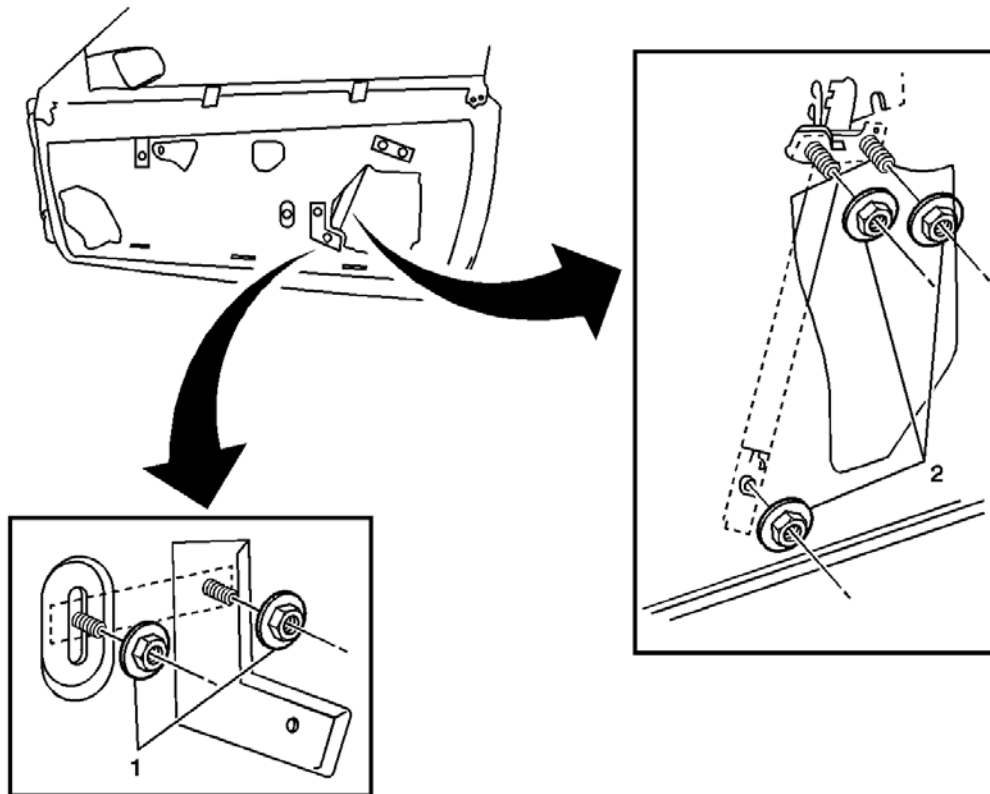
**Figure 29**

The glass is not parallel to the weatherstrip or is not contacting the up stops at the same time.

The glass is forward or rearward.

2. Loosen the inner panel cam attachments. Refer to item 1 in Figure 29. The front attachment is slotted for adjustment
3. Position the glass parallel to the weatherstrip and tighten the attachments.

Tighten the attachments to 10 N·m ( 89 lb in).

1. Loosen the rear guide channel attachments. Refer to item 2 in Figure 29.
2. Position the glass to the desired location and tighten the attachments.

Tighten the attachments to 27 N·m (20 lb ft).

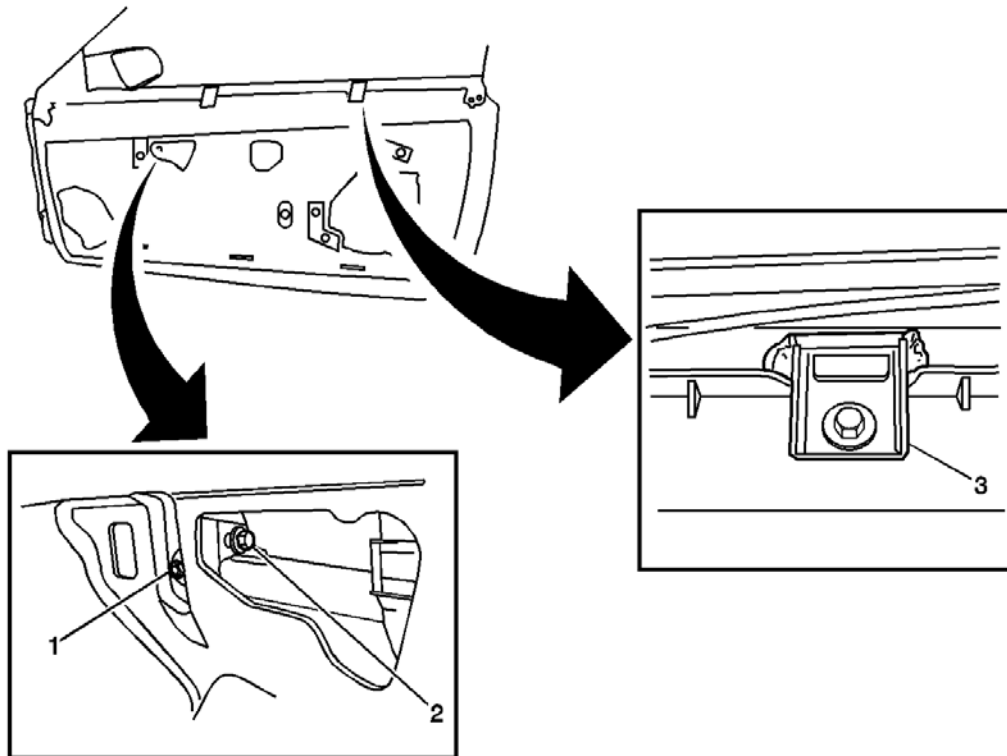
## **Figure 30**

This glass is up or down at the front.

The upper edge of the glass is inboard or outboard.

- Loosen the front up stop attachment. Refer to item 1 in Figure 30.
- Position the glass to the desired location and tighten the attachments.

Tighten the attachments to 10 N·m (89 lb in).

1. Loosen the rear guide channel attachments
2. Loosen the front up stop in/out attachment (access through the hole in inner panel rearward of the front up stop). Refer to item 2 in Figure 30.

Belt stabilizers will reduce noise during glass travel or improve glass stability. Refer to item 3 in Figure 30.
