DEXRON®-VI

Techline News

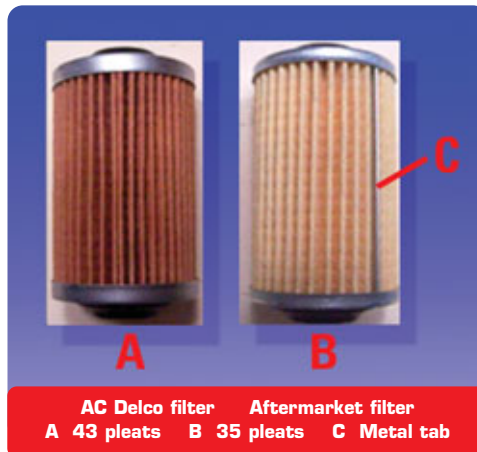
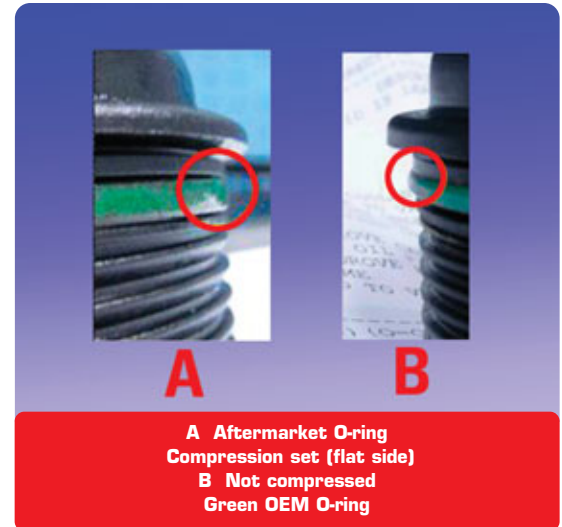
The filtering capacity of an oil filter is dependent on the surface area of the filter paper. This is dependent on the number of pleats, or folds. In the photo, the AC Delco filter on the left has 43 pleats in the filter paper. The aftermarket filter on the right is marketed as a premium filter. It has only 35 pleats. It has a metal joining tab for the filter element, which further reduces the filter surface area.

Some aftermarket filters are manufactured with inferior parts which can damage an engine. For instance, the orange rubber material from an oil filter anti-drainback valve has migrated to the oil passages of the engine in the next photo. At best, the material will restrict flow and slowly cause damage. At worst, it will block passages and quickly damage the engine.

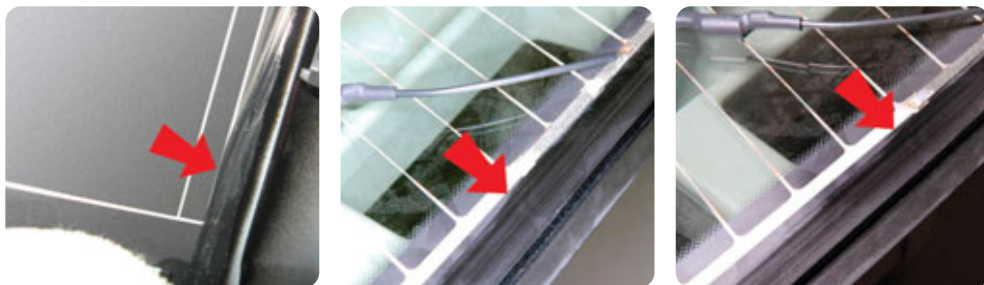
Remove the necessary trim and parts for inspection of the perimeter of the glass. The minimum clearance for the urethane or primer to any silver printing on the surface of the glass must not be less than 11 mm.

TIP: The urethane and primer are conductive and degrade radio performance.

If the urethane or primer extends over the silver antenna printing, the glass must be replaced.

If the urethane or primer does not extend over the silver antenna printing, remove any urethane or primer along the glass perimeter that does not meet the 11 mm specification.

Use extreme caution when eliminating the excess urethane or primer on the glass. Tape the silver antenna printing on the glass with blue painter's tape. Be careful not to damage, cut or scrape any of the silver antenna printing and blackout on the glass. And do not damage or disrupt any electrical connections attached to the glass.

Before reassembly, measure the distance between the urethane or primer and the silver printing on the glass to verify compliance to the specification.

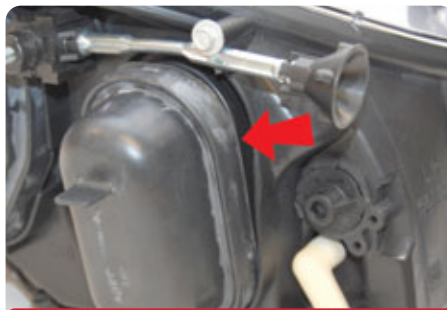
Customers may notice moisture formed inside the headlamp lens. This may be caused by the rubber headlamp bulb access covers not being installed properly. There is a separate cover for each of the four headlamp bulbs. If a cover is not properly seated, water can leak into the headlamp housing and condense on the inside of the lens.

High beam cover loose

Be sure all four covers are present and properly seated. If a cover is missing, service replacement parts are available.

Simply press the flange of the cover fully into the locating groove.

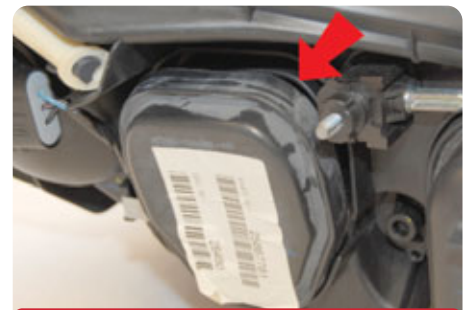
Low beam cover loose

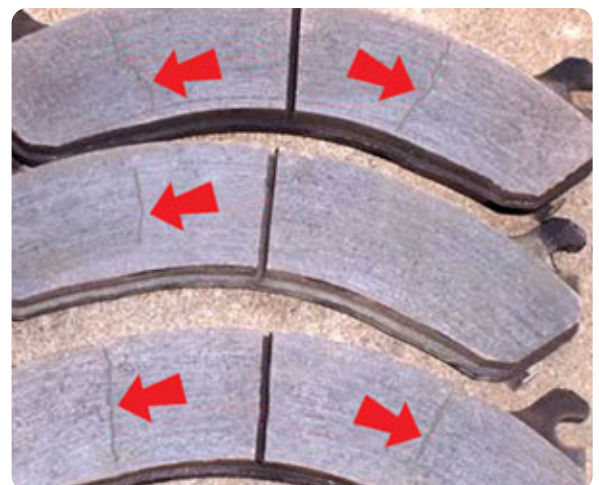
When performing a brake inspection on a 2007-09 Chevrolet Silverado 3500HD or GMC Sierra 3500HD with brake RPO JK4 or JH7, hairline cracks may be noticed in the pad friction material. Cracks in the friction material can occur after the pads have been subjected to high pad temperatures.

These hairline cracks do not affect the operation of the brake system and the pads should not be replaced if only hairline cracks are found.
