Subject: 1992 CORVETTE LT1 ENGINE BALANCING

also 93-96

1992 CORVETTE
FLYWHEEL TRIAL BALANCE PROCEDURE

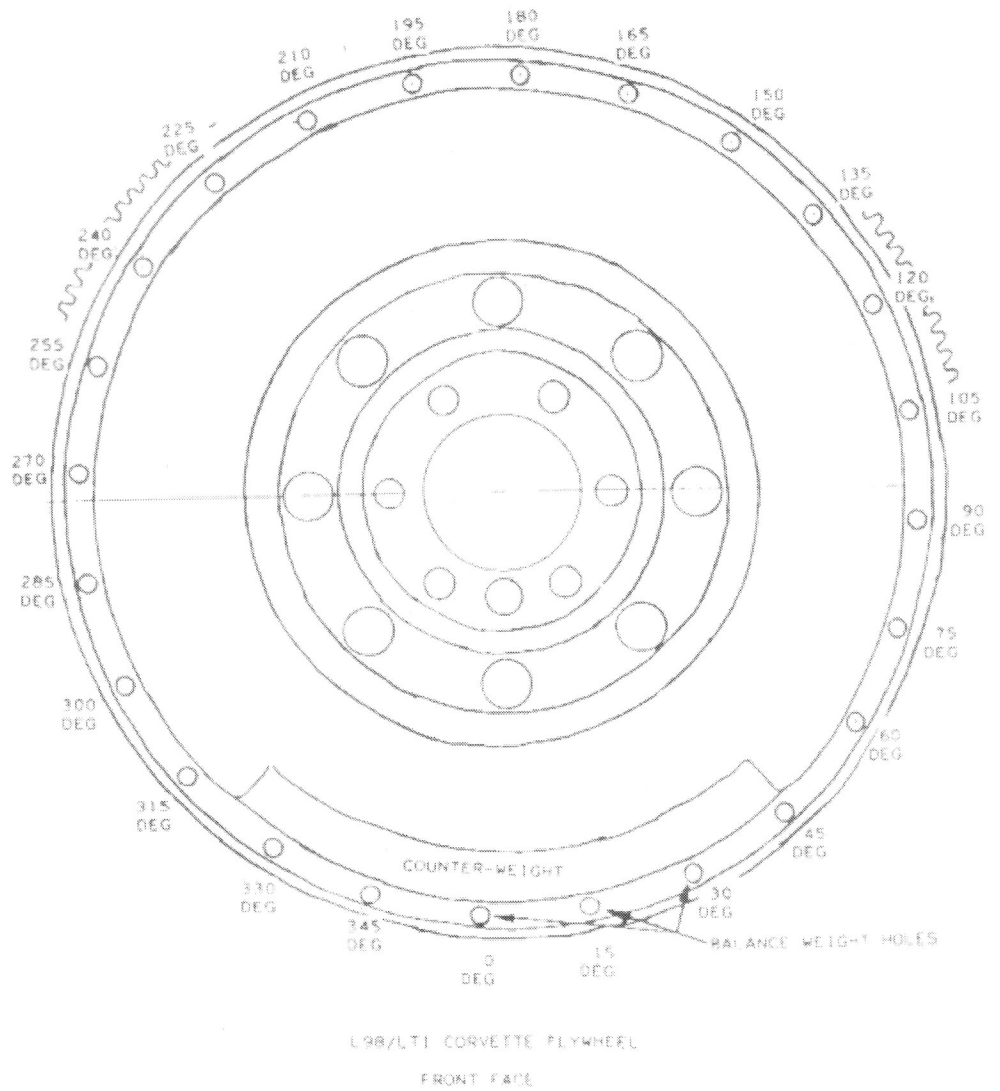
Results of re-balancing engines in 65 1992 LT1 Corvettes have shown a concentration of unbalance in a specific sector of the flywheels. The attached plot is a polar representation of the unbalance magnitude and position for the cars tested. The angular system corresponds to the flywheel as viewed from the front with the "zero" point at the locating dowel (approximately centered on the cast-in counterweight near the rim) the angles increasing counter-clockwise.

Assuming the 65 engines re-balanced are representative of the total population of engines produced, acceptable balancing of most of the cars should be possible by installing balance weights in the area of most frequent unbalance. Specifically, four patterns of weights have been identified that would produce flywheel unbalance at 4200 RPM of 1.0 in-oz or less in 90% of these engines. These are represented on the plot as diamonds; the circles are 1.0 in-oz radius about these points.

- 1) The starter and oil filter are removed to gain access to remove the clutch housing front cover.
- 2) Starter and oil filter are re-installed.
- 3) Using a sharp pointed paint pencil, mark the balance holes in the flywheel corresponding to the attached sketch.
- 4) Engine is brought up to operating temperature (at least 140°F coolant).
- 5) Operate the engine with the clutch released (foot on pedal) between 4000 and 5000 RPM and carefully note vibration level.
- 6) Install balance weights at first trial location. The attached table and drawing describe these patterns.

90	105	120	135	150	165	180	195
TRIAL 1: 2.35 in-oz @ 172.5 Deg.					X	X	X	X
TRIAL 2: 2.35 in-oz @ 142.5 Deg.			X	X	X	X		
TRIAL 3: 1.80 in-oz @ 120.0 Deg.		X	X	X				
TRIAL 4: 3.74 in-oz @ 135.0 Deg.	X	X	X	X	X	X	X
