TCC ENABLE SOLENOID ELECTRICAL CIRCUIT FAULT 67/90/P0740/P1864/P2769/P2770 (4L60E/70E ONLY)

TCC ENABLE SOLENOID ELECTRICAL CIRCUIT FAULT 67/90/P0740/P1864/P2769/P2770 (4L60E/70E ONLY)...continued

3-2 SOLENOID ELECTRICAL CIRCUIT FAULT 66/84/P0785/P0787/P0788/P1886 (4L60/65/70/75E ONLY)

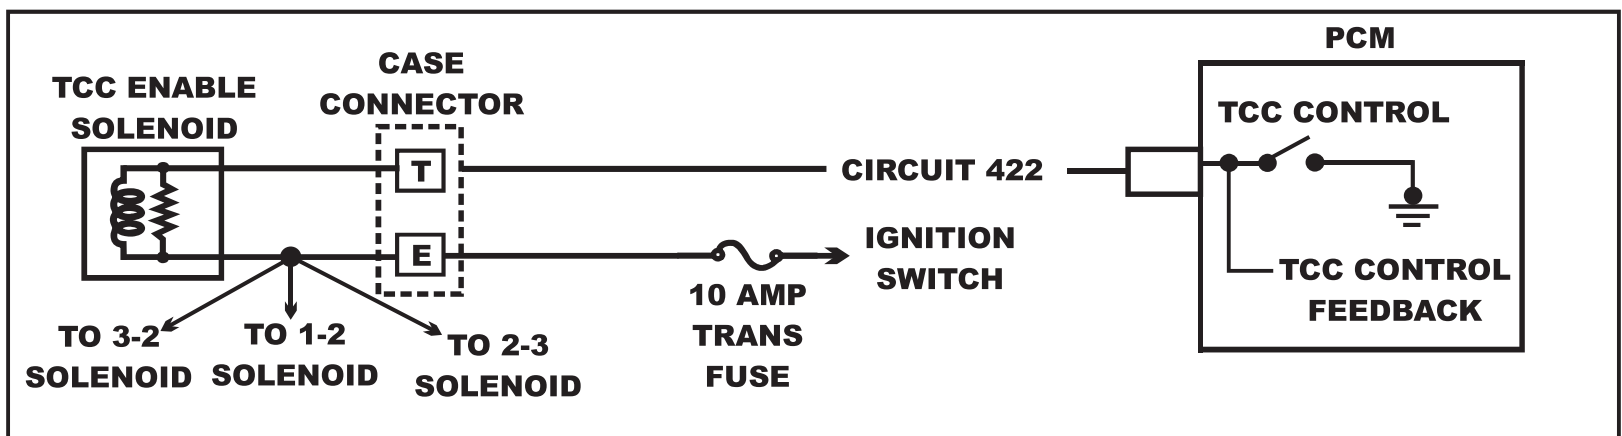
Figure 108

- The TCC Enable Solenoid is faulty.
- A short to power or ground on Circuit 422, (Refer to Figure 108).
- An open in Circuit 422, (Refer to Figure 108).
- A Blown Fuse, causing power loss to case connector terminal “E”,(Other solenoid codes should be stored).
- A faulty ignition switch, Causing intermittent power loss to case connector terminal “E”, See Figure 109 for terminal “E” location. (Other solenoid codes should be stored, use relay harness to bypass ignition switch as shown in Code 81,82, P0753 & P0758 diagnostics.
- Damaged terminal ends, Refer to Code 81,82, P0753 & P0758 diagnostics on how to check terminal cavities, See Figure 109 for terminal”T” location.
- A faulty computer.

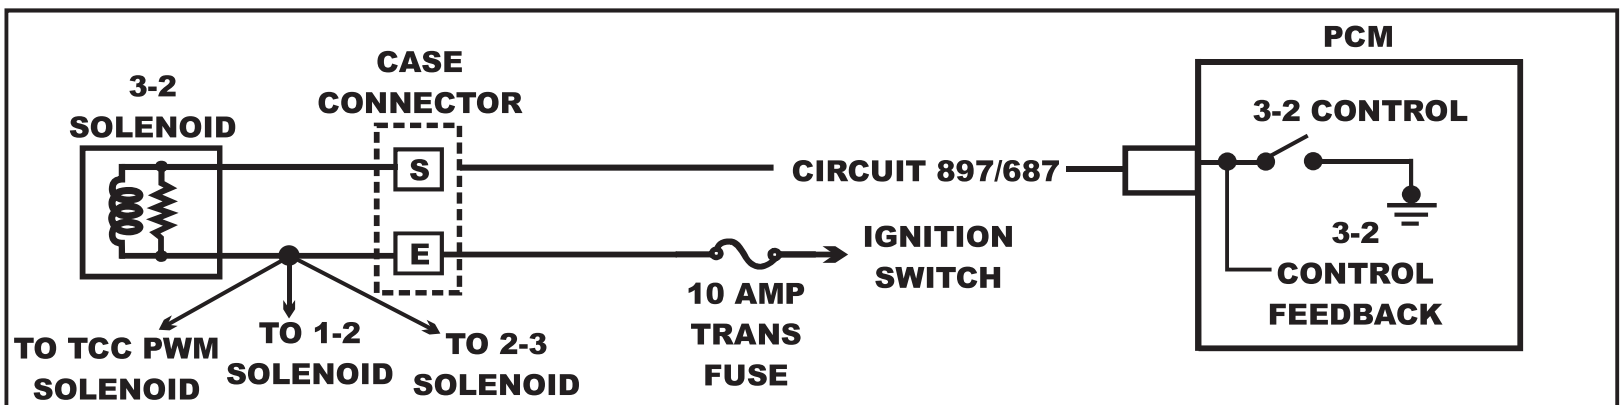
Figure 116

- The 3-2 Solenoid is faulty.
 - Switching the 3-2 ON/OFF Solenoid with the TCC PWM Solenoid (1996 & Later).
 - Faulty internal wire harness.
 - A short to power or ground on Circuit 897 or 687, (Bulkhead connector damage).
 - An open in Circuit 897 or 687.
 - Damaged terminal ends.
 - Water or oil intrusion of the case connector.
 - A Blown Fuse, causing power loss to case connector terminal "E", (Other solenoid codes should be stored).
 - A faulty ignition switch, causing intermittent power loss to case connector terminal "E". (Other solenoid codes should be stored).
 - A faulty computer.

- Replace 3-2 solenoid.
 - Make certain the correct 3-2 solenoid is used for the application, PWM 1993-1995(10-15 Ohms), ON/OFF 1996 and later, (20-30 Ohms), Refer to Figure 117.
 - Replace wire harness, aftermarket parts are available.
 - Repair wiring as necessary by referring to the diagram in Figure 116.
 - Check terminal end cavities with a #59 wire gauge drill bit. Refer to Figure 118 for terminal location. Transmission wiring on "G" Vans is routed between the floor of the van and a sheet metal plate, wiring can deteriorate in this area, check for bulk head connector damage as well.
 - Repair short and replace fuse.
 - Replace ignition switch or use relay wire harness as shown in Figure 125.
 - Replace computer, new or rebuilt computers must be programmed or vehicle will not start.
