## #00-08-110-004: Rear Quarter Trim Gaps to the B-Pillar (Insert Screw) - (Oct 11, 2000)

**Subject:** Rear Quarter Trim Gaps To The B-Pillar (Insert Screw)

**Models:** 1998-2000 Chevrolet Camaro (Coupe)  
1998-2000 Pontiac Firebird (Coupe)

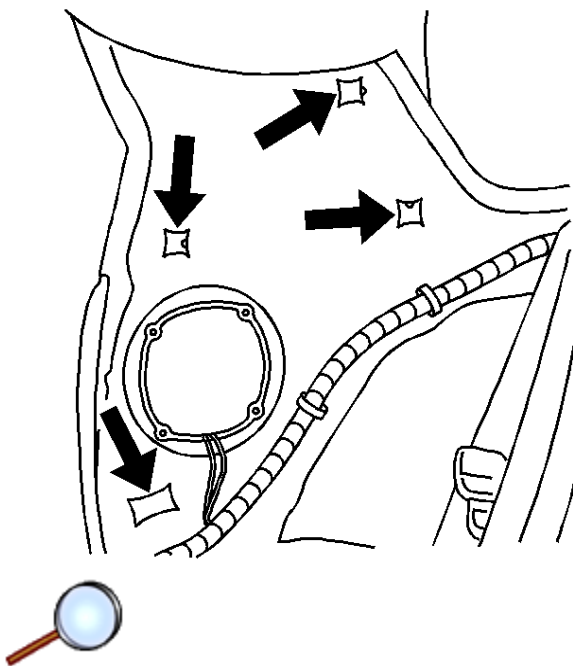
Figure 1

2. Make sure the quarter trim panel is seated to the Velcro attachment points. See Figure 1.

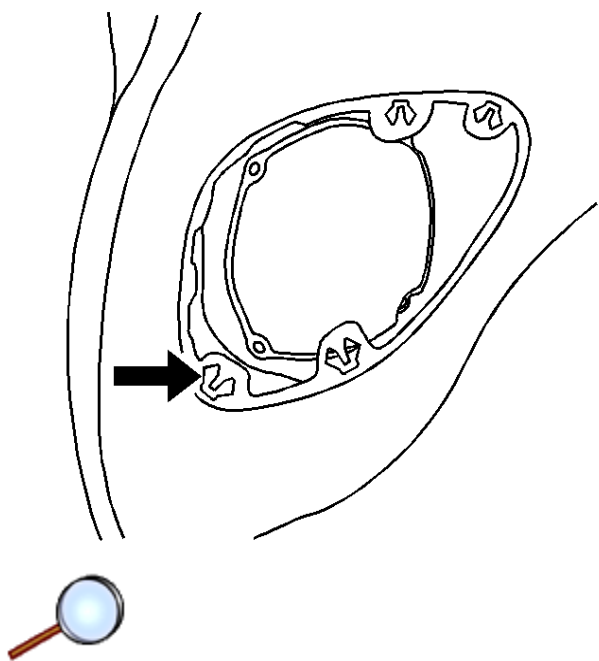
Figure 2

3. Drill and insert the screw to secure the trim panel to the body. See location shown in Figure 2.
4. Reinstall speaker cover.
