TCC ENABLE SOLENOID ELECTRICAL CIRCUIT FAULT 67/90/P0740/P1864/P2769/P2770 (4L60E/70E ONLY)

TCC ENABLE SOLENOID ELECTRICAL CIRCUIT FAULT 67/90/P0740/P1864/P2769/P2770 (4L60E/70E ONLY)...continued

3-2 SOLENOID ELECTRICAL CIRCUIT FAULT 66/84/P0785/P0787/P0788/P1886 (4L60/65/70/75E ONLY)

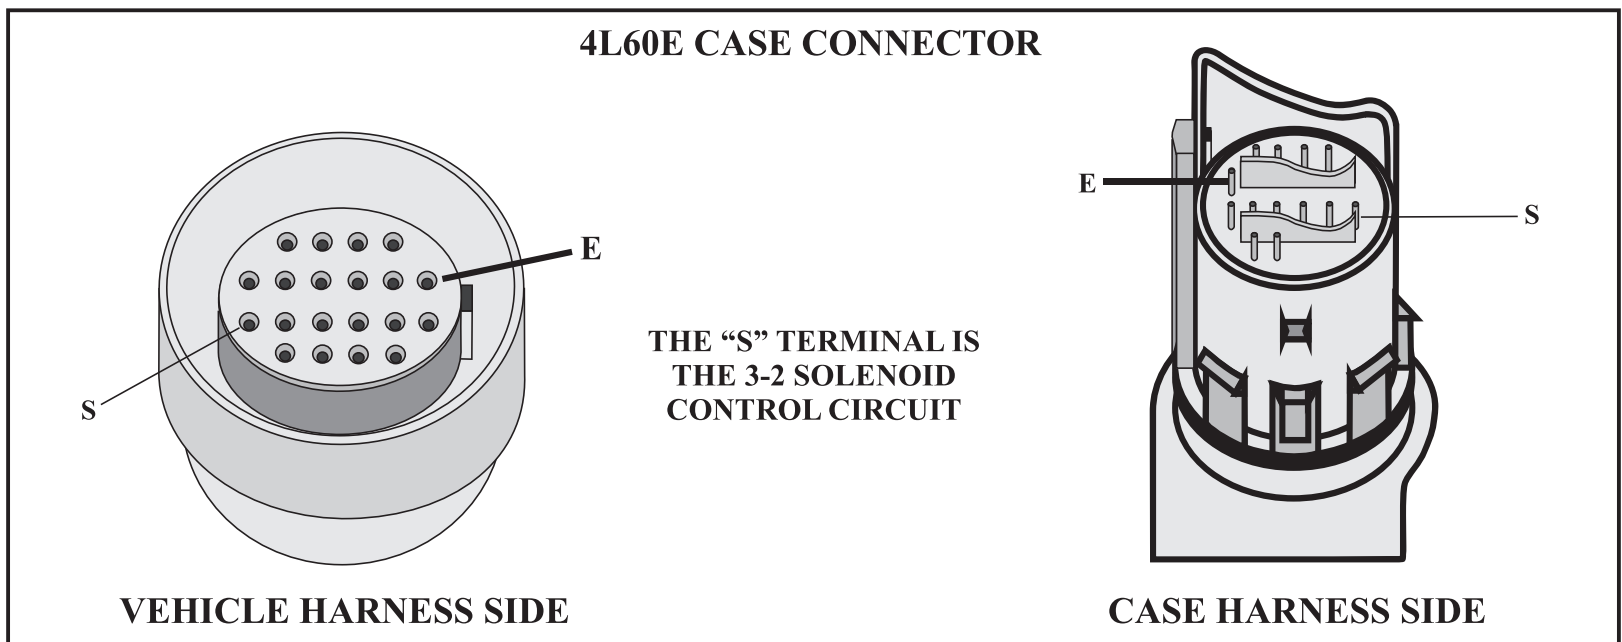
Figure 117

- The 3-2 Solenoid is faulty.
 - Switching the 3-2 ON/OFF Solenoid with the TCC PWM Solenoid (1996 & Later).
 - Faulty internal wire harness.
 - A short to power or ground on Circuit 897 or 687, (Bulkhead connector damage).
 - An open in Circuit 897 or 687.
 - Damaged terminal ends.
 - Water or oil intrusion of the case connector.
 - A Blown Fuse, causing power loss to case connector terminal "E", (Other solenoid codes should be stored).
 - A faulty ignition switch, causing intermittent power loss to case connector terminal "E". (Other solenoid codes should be stored).
 - A faulty computer.

- Replace 3-2 solenoid.
 - Make certain the correct 3-2 solenoid is used for the application, PWM 1993-1995(10-15 Ohms), ON/OFF 1996 and later, (20-30 Ohms), Refer to Figure 117.
 - Replace wire harness, aftermarket parts are available.
 - Repair wiring as necessary by referring to the diagram in Figure 116.
 - Check terminal end cavities with a #59 wire gauge drill bit. Refer to Figure 118 for terminal location. Transmission wiring on "G" Vans is routed between the floor of the van and a sheet metal plate, wiring can deteriorate in this area, check for bulk head connector damage as well.
 - Repair short and replace fuse.
 - Replace ignition switch or use relay wire harness as shown in Figure 125.
 - Replace computer, new or rebuilt computers must be programmed or vehicle will not start.
