DEXRON®-VI

Techline News

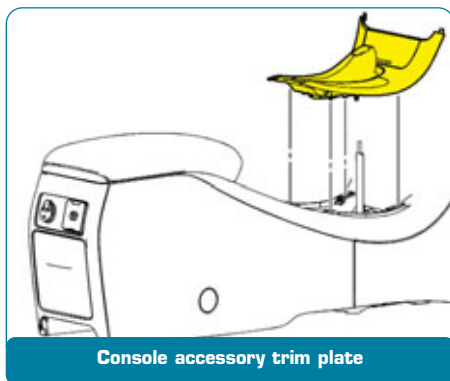
Console accessory trim plate

On the Malibu, if the IP accessory trim plate is removed incorrectly, it may be damaged. There are 2 hidden screws and 8 clips. Here are some tips.

1. Remove the shift control knob.
2. Use a flat bladed plastic trim tool to release the retaining clips on the bottom side of the front floor console accessory trim plate. Remove the trim plate. Disconnect electrical connections.

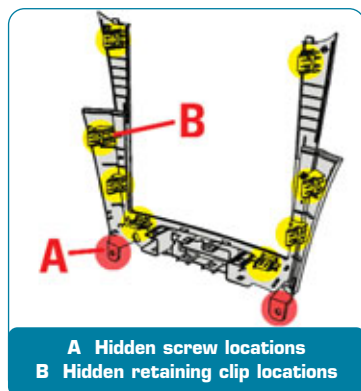
A Hidden screw locations
B Hidden retaining clip locations

3. This gives access to remove two hidden screws at the bottom of the IP accessory trim plate.
4. Use a flat bladed plastic trim tool to release the retaining clips on the back side of the IP accessory trim plate. There are three on each side of the opening, and an additional two below the opening. Disconnect electrical connections.
5. Lift the IP accessory trim plate away from the instrument panel.

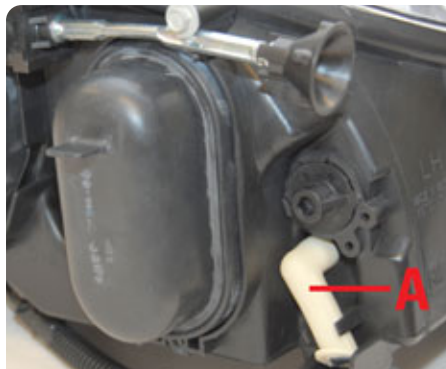
Customers may notice moisture formed inside the headlamp lens. This may be caused by the rubber headlamp bulb access covers not being installed properly. There is a separate cover for each of the four headlamp bulbs. If a cover is not properly seated, water can leak into the headlamp housing and condense on the inside of the lens.

High beam cover installed
A Vent tube

Be sure all four covers are present and properly seated. If a cover is missing, service replacement parts are available.

Simply press the flange of the cover fully into the locating groove.

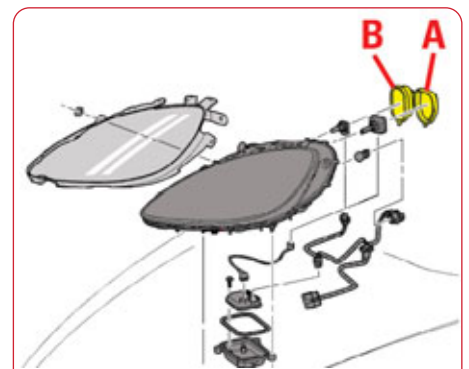
A Cover, Low Beam 12335924
B Cover, High Beam 12335925

After the covers are properly installed and headlamps are turned on, moisture will evaporate and pass from the housing through the vent tube.
