# SK 700-G™ Shift Kit®

## TransGo® COMPLETE SYSTEM CORRECTION SysKo® Kit The Genuine Fix: Even for the “Authorized Complaints” VALVEBODY, SERVO, ACCUM, GOVNR, PUMP PARTS/DATA

### PARTS AND INFO— FOR PREVENTION/CORRECTION OF THE FOLLOWING COMPLAINTS AND FAILURES:

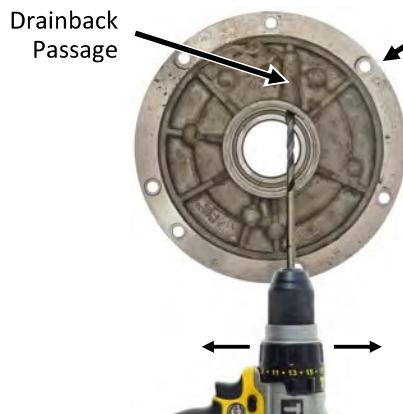
**IF THE TRANS IS OUT**—Enlarge the seal drainback passage to reduce LEAKS and keep the seal from blowing out. Use a 1/4"-9/32" drill (.250-.281)

**"Bell Mouth"** the drainback hole:  
To increase flow, after enlarging the passage, insert the drill again into the hole about 3/4". Move the drill motor — Leftward and Rightward to widen the top of the hole.

**THE PROBLEM:** Clearances and wear allow more oil to enter seal area than the drainback hole can handle. Pressure builds under seal causing the seal to blow out of the pump or leak.

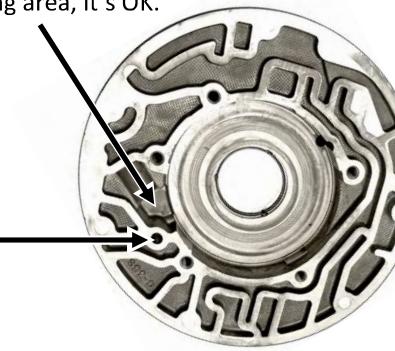
Use the same drill to check or enlarge the holes shown in the pump and pump cover.

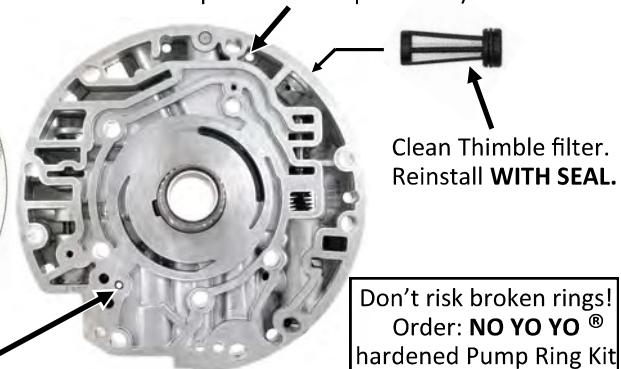
### —IF THE TRANS IS OUT AND APART—

Look at the left end of this passage. If it has an open hole that the orifice plug furnished will fit, drive it in it. Otherwise: Tap it two or three threads deep and insert a piece of 1/4" bolt.

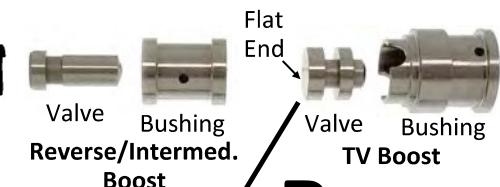
After installing the boost valve snap ring, push it in deeper with a screw driver, to be sure it has snapped into its groove.

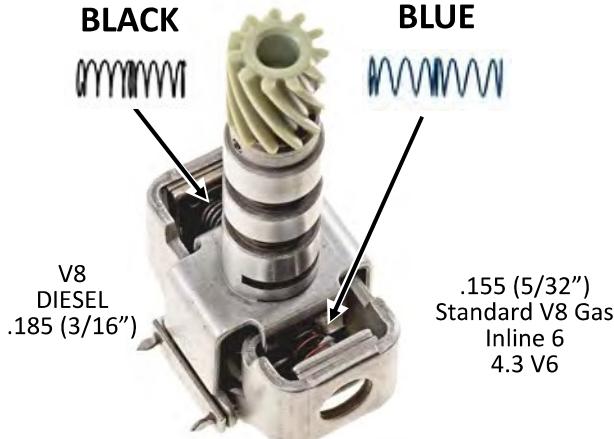
## STANDARD V8 GAS & DIESEL

Also: Inline 6 & 4.3 V6

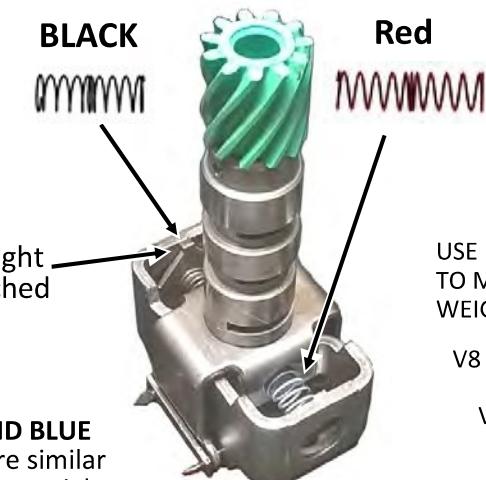
## V8 — HI-OUTPUT

MOST—VETTE—Z-28—TRANS AM

USE PRINTED LINES  
TO MEASURE GOVNR  
WEIGHT THICKNESS

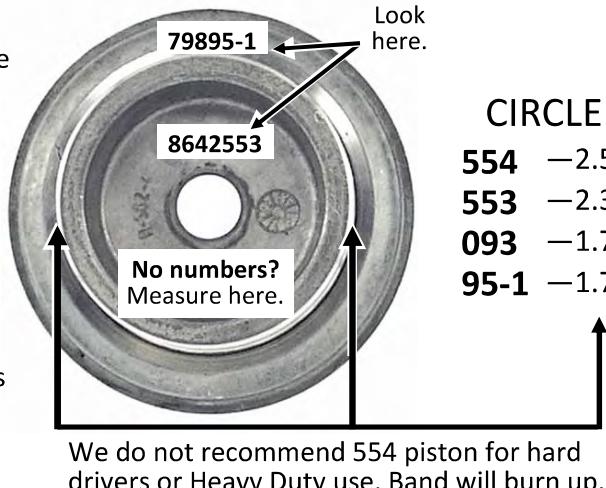
### 2nd Piston Number/Diameter

554 is light duty— Not for V8's or turbo.  
553 is medium duty— V6, V8 Cars & Trucks  
093 or 95-1 - H.D. or High Output  
(Aftermarket "Corvette Servo" is same as 093, 95-1. Our servo p/n is 7-2P )

- 554 — 2.519"
- 553 — 2.312
- 093 — 1.792
- 95-1 — 1.792

V8 gas and diesels need **553** piston. Using the **554** piston in these models can cause 2nd band burnup and/or 2-3 cutloose.

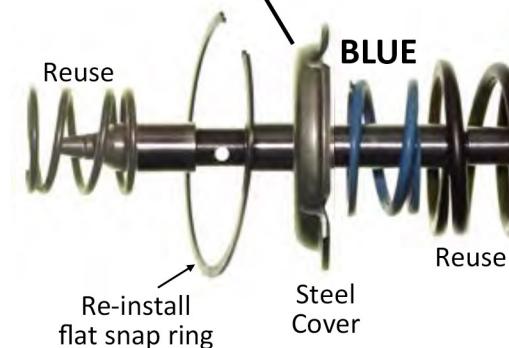
Grind 4 oil exit notches on Steel Cover about like this. While grinding notches it gets hot, so have a dish of water handy.

Install the **BLUE** spring inside of original cushion spring. Grind 4 notches on steel cover as shown. Re-install steel cover & flat snap ring. Install **RED** O'ring on 2nd piston housing.

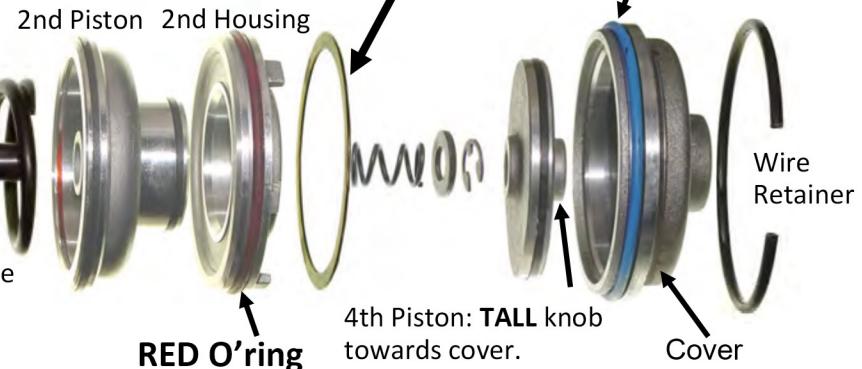
Band adjustment shim. Use none or 1 to adjust band.

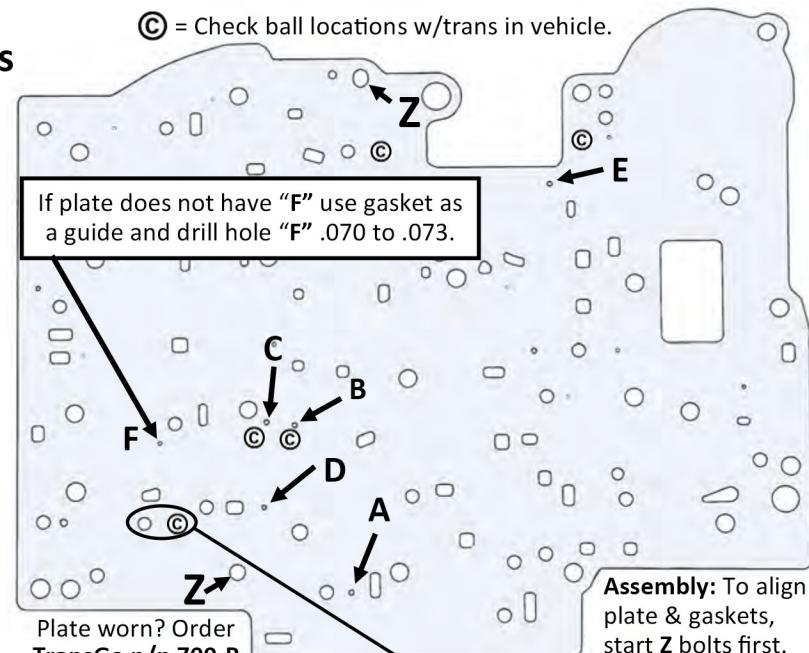
# Step 5. Plate Hole Sizes

**Please use these hole sizes.** They are matched to the accumulator and servo changes furnished in this kit.

**Got a hole too big?** Place the hole that's too big onto the face of a sprag race. (Hardened Surface) Place 5/16 steel ball on the hole and hit it with a small hammer. Redrill to correct size.

**Assembly:** To align plate & gaskets, start **Z** bolts first.

2. Installing bolts into holes "Z" shown on the instructions and tightening the hold-down plate is a must. If you don't do it that way, it is easy to not get the plate tightened and have some crazy shifts. 3. If you don't get the TV bellcrank mechanism lined up on the roll pin and you tighten the bolt it will BEND the bracket. The side of the bracket will then rub against the plunger and hang it up. We have also found that sometimes the bracket is bent from bad original installation or from someone giving it way too much TV. Here is how we check it: Install the bracket. Make sure the bracket clears the plunger. Rotate the arm and see that it bottoms the plunger by the time it gets to the middle of the TV cable hole.

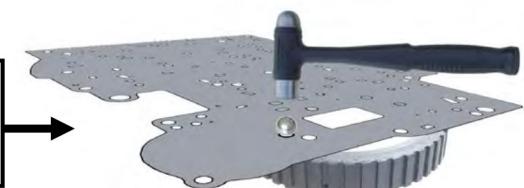
If plate has these 2 holes: Install #9 check ball (82-87)  
Don't install check ball: If plate has only 1 hole. (88up)

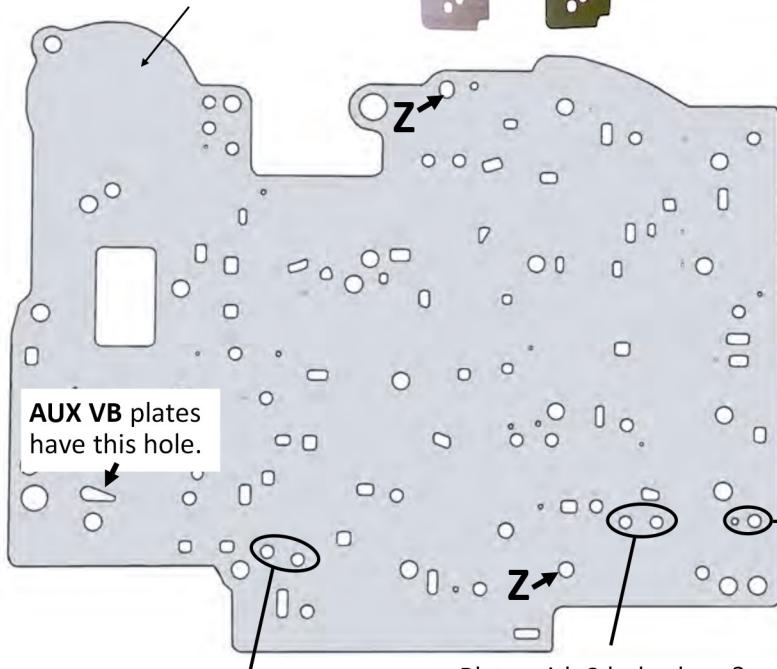
# Step 6. CASE, PLATE & 4th ACCUM

When installing the valve body: Install the "Z" bolts first and tighten them. The rest of the bolts will then go in and tighten easily.

**2nd Accumulator:** Some early models may have an "extra" stiffener plate and gasket here.

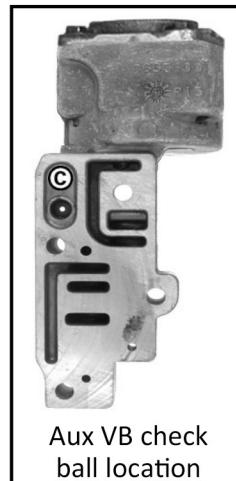
Aux VB check ball location

- Plate with 2 holes here?  
Install #9 Ball. 82-87
- Plate with only 1 hole here?  
Do not use #9 88up

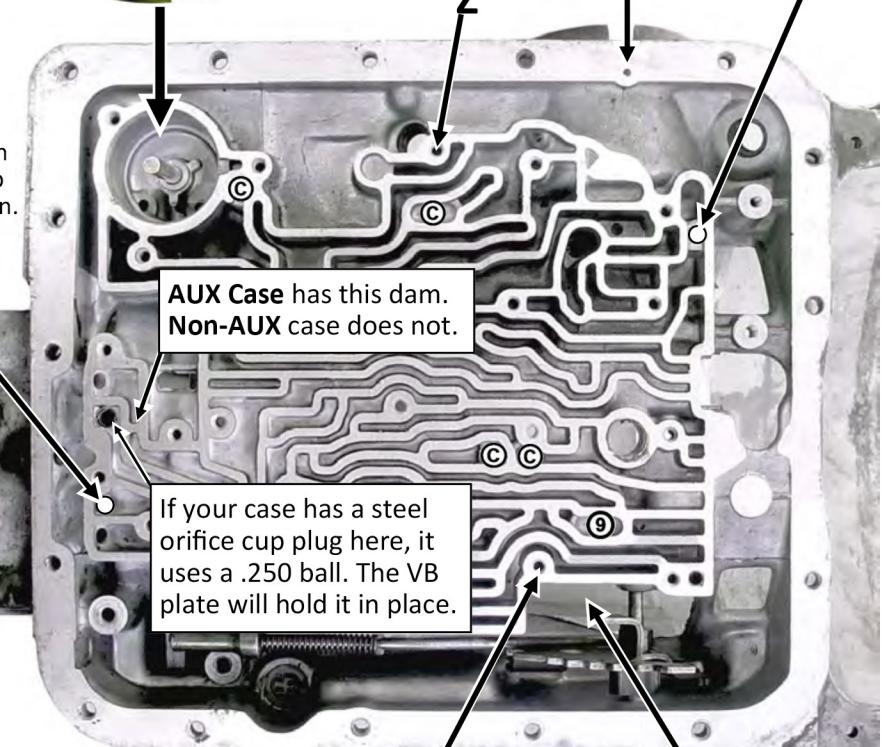
**A.** **Install YELLOW spring into case first.**  
Install **seal furnished** that fits the piston groove correctly and installs in the bore snugly. Insert piston with legs first into the case as shown.

This may be different from how you found it. It's OK, it improves the 3-4 shift feel.

Look here when checking band clearance. Band must wiggle on drum at least 1/8" ← →

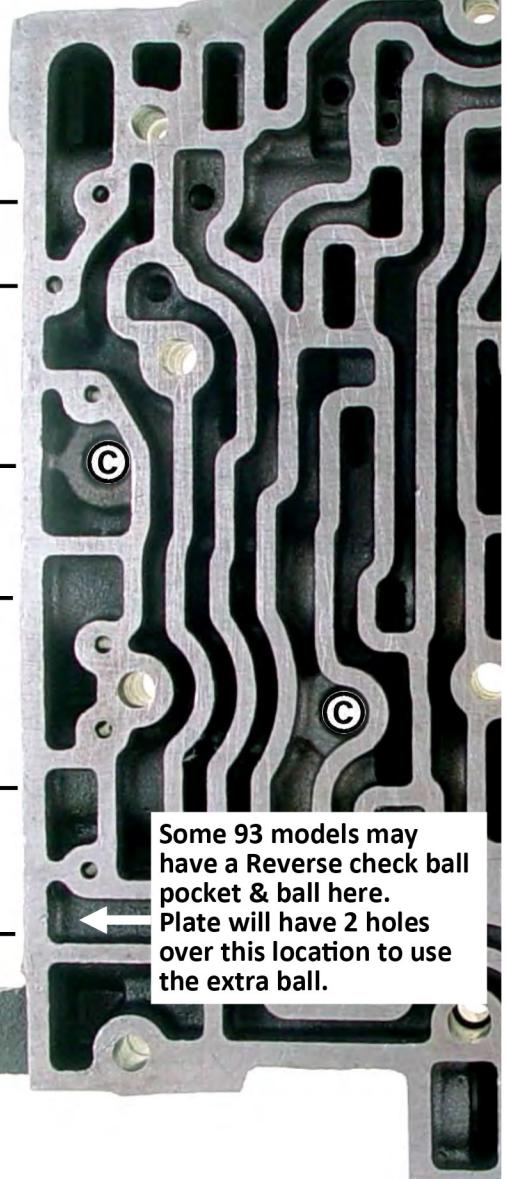
TCC Shift

Later models deleted  
TCC shift valves & bore.  
It's casted closed.

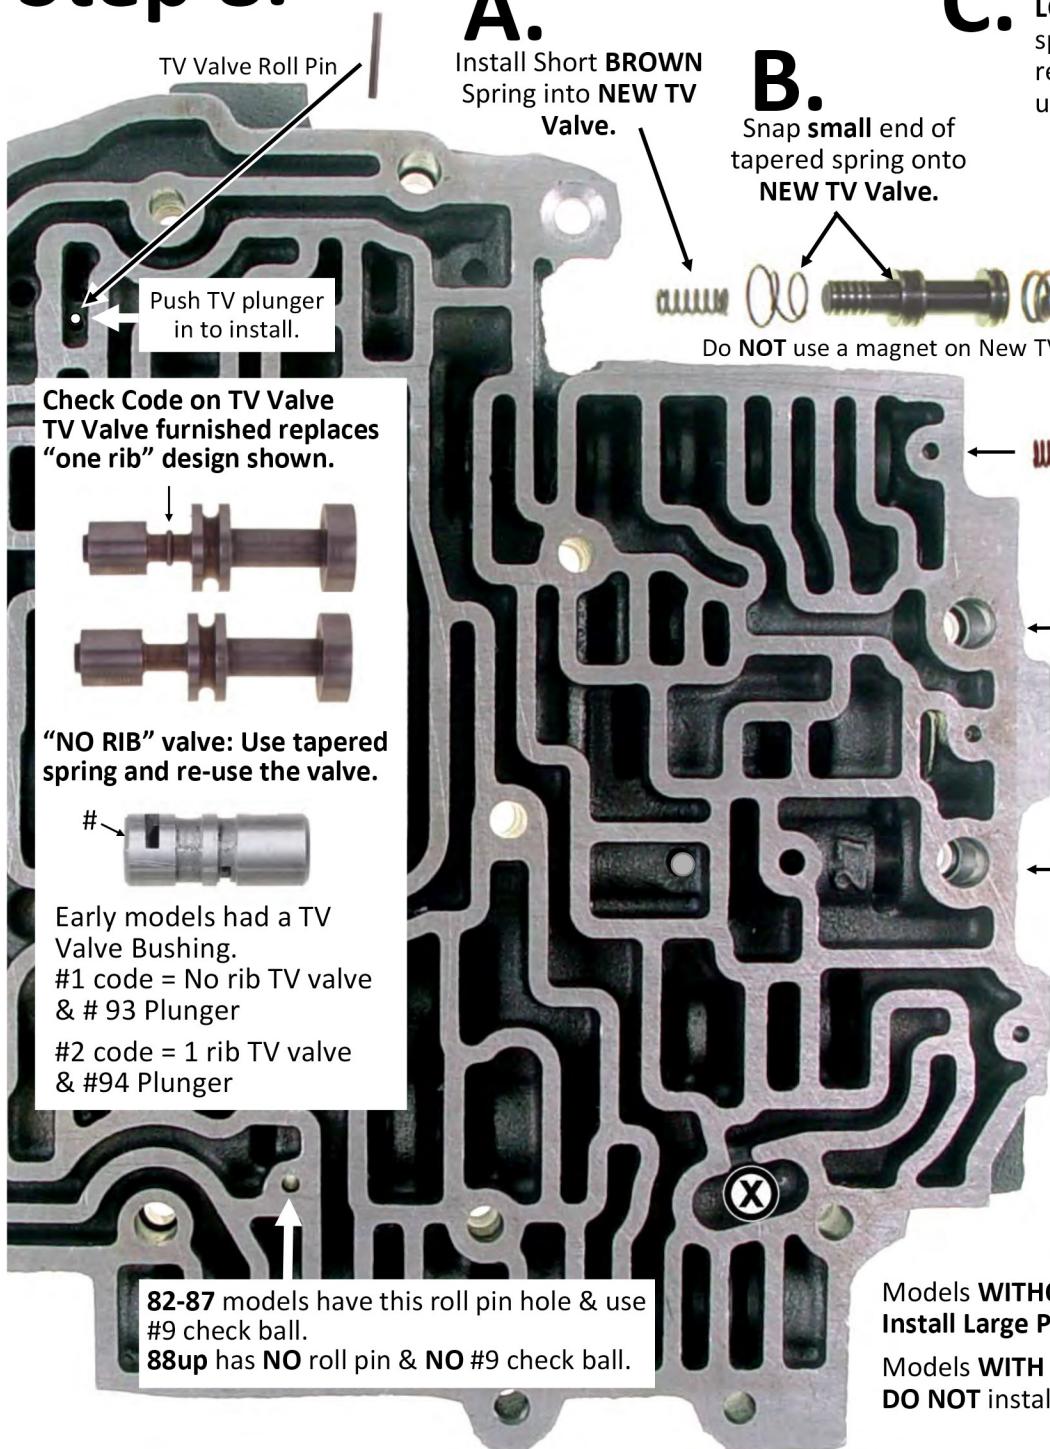
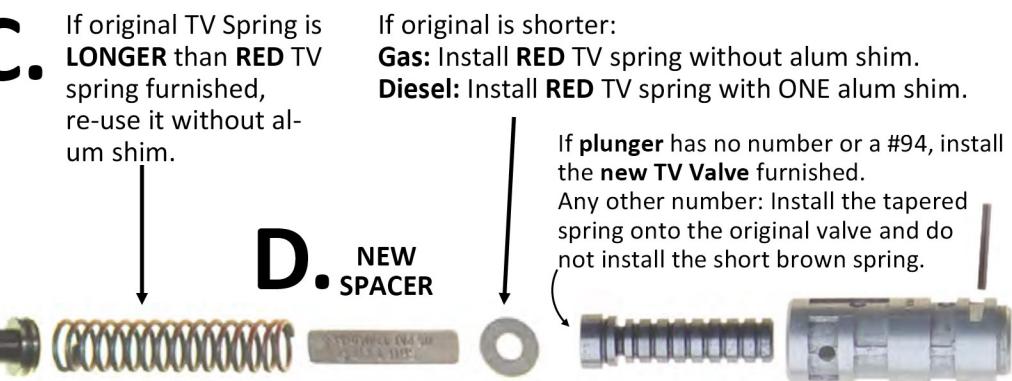
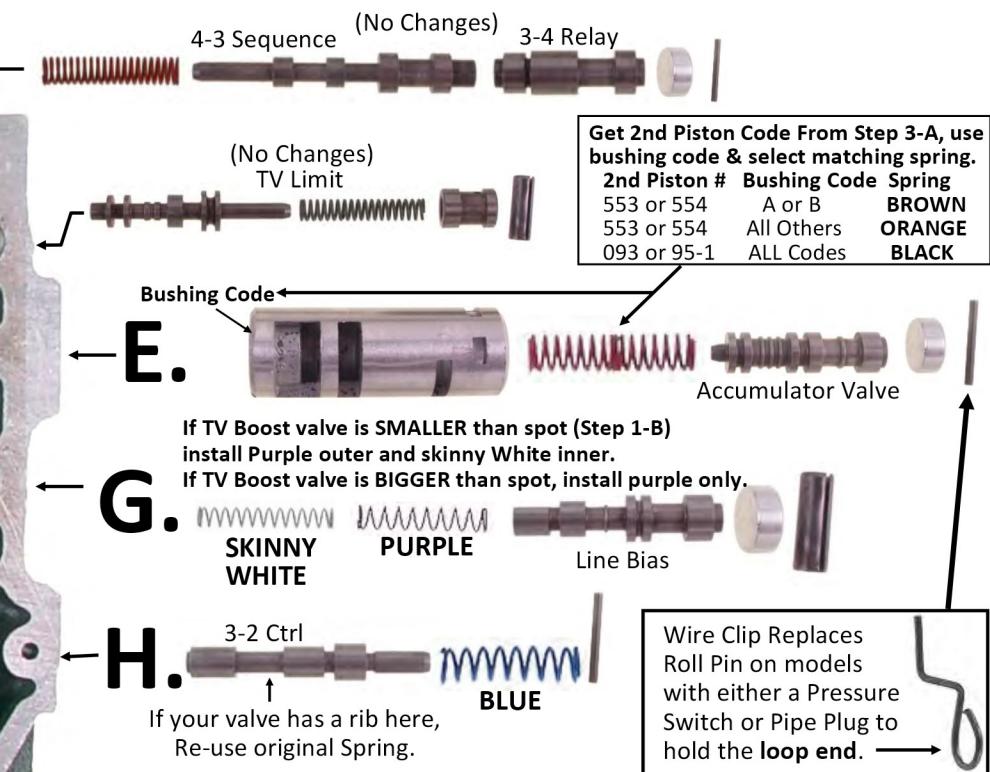
# Step 8.

**Accumulator Valve Note:** A wire clip retainer has been furnished to allow spring changes on the accumulator valve without removing the valve body.

**No pipe plug or switch?** Reuse original roll pin.

1-2 Accum Spring Firmness Selection:  
**Softest** - Black - Brown - Orange - **Firmest**  
 Always start with the chart recommendations.  
 Larger 2nd Piston size adds firmness also. See step 3A

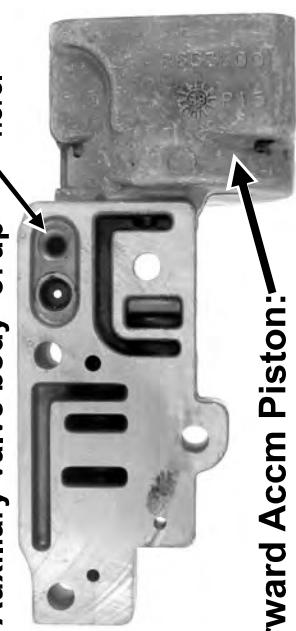
**Forward Accm Piston:**

**Uses CHECKBALL here.**

**Install a seal furnished that fits the groove correctly and installs in the bore snugly.**

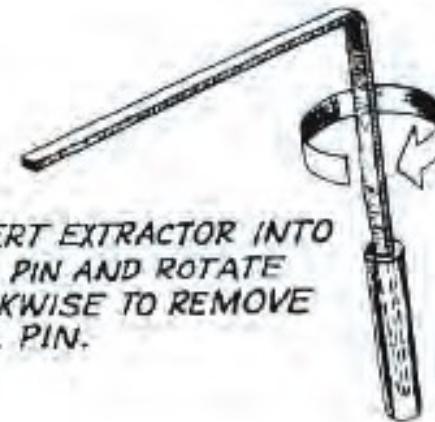
←  $1\frac{1}{8}$ " APPROX. →

INSERT EXTRACTOR INTO  
ROLL PIN AND ROTATE  
CLOCKWISE TO REMOVE  
ROLL PIN.
