Document ID# 679172
2001 Pontiac Firebird

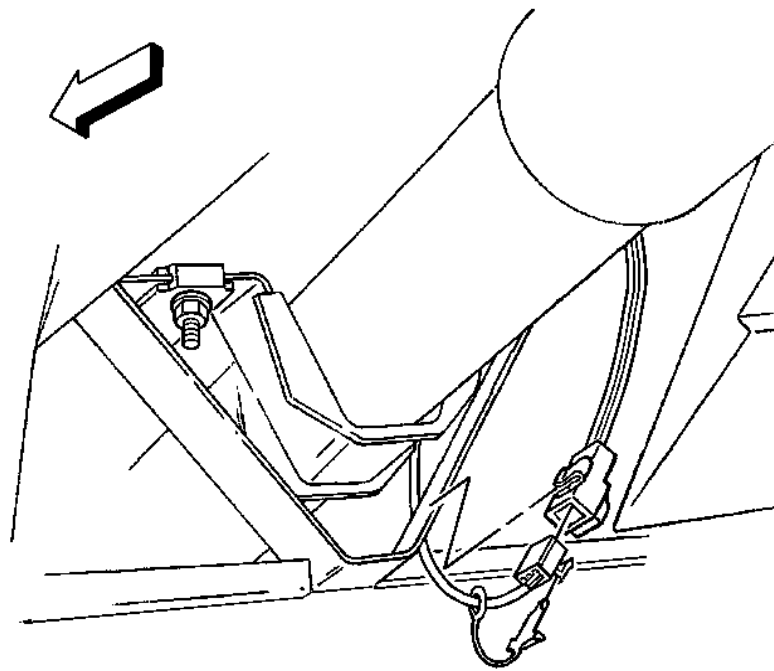
6. Remove the left instrument panel insulator. Refer to [Closeout/Insulator Panel Replacement - Left](#) in Instrument Panel, Gages, and Console.
7. Remove the connector position assurance (CPA) from the inflatable restraint steering wheel module coil connector located at the base of the steering column.

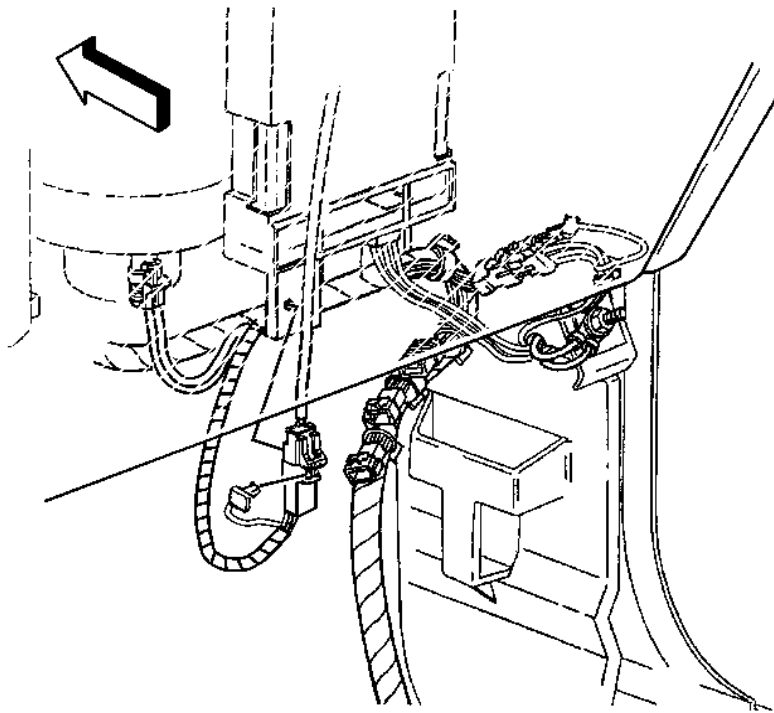
8. Disconnect the steering wheel module coil connector located at the base of the steering column.
