Vehicle: Connector Views

2001 Chevrolet Camaro V8-5.7L VIN G Copyright © 2008, ALLDATA 9.90 Page 2

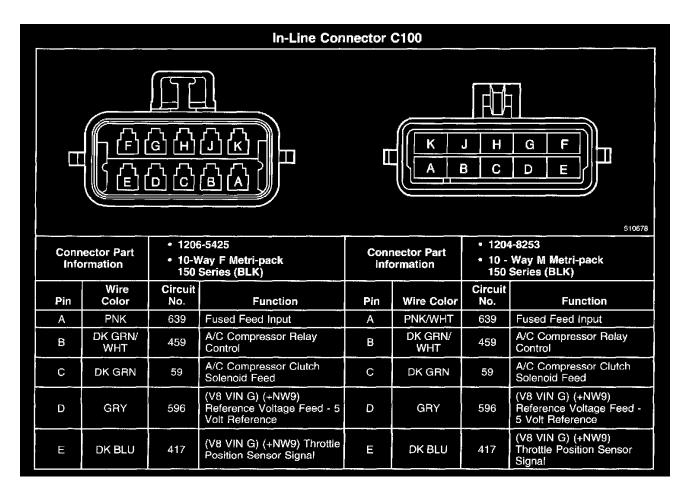
In-Line Connector C100 (Part 1 Of 2)

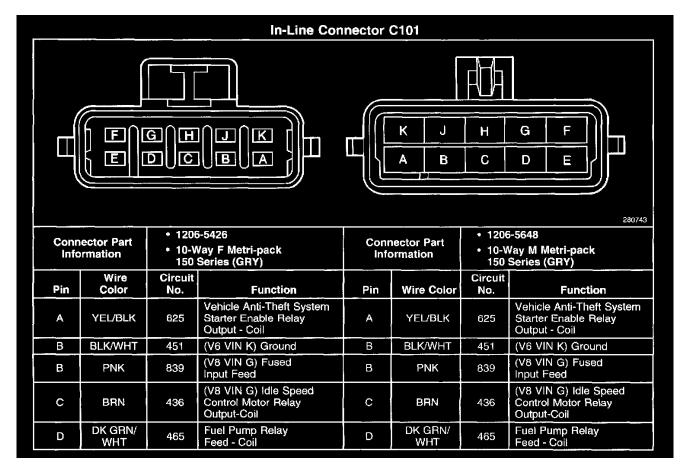
In-Line Connector C101 (Part 1 Of 2)

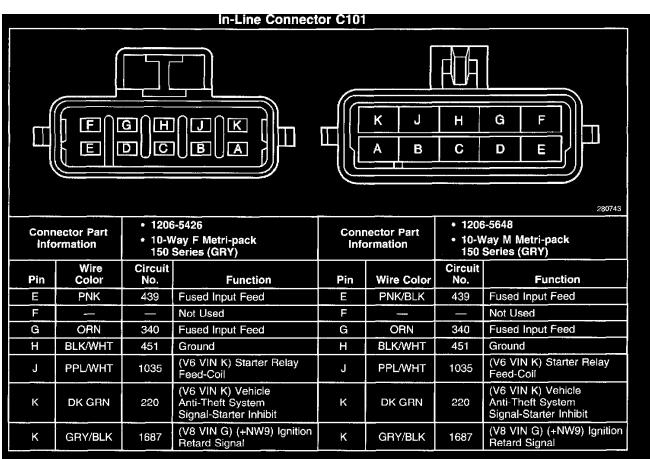
In-Line Connector C101 (Part 2 Of 2)

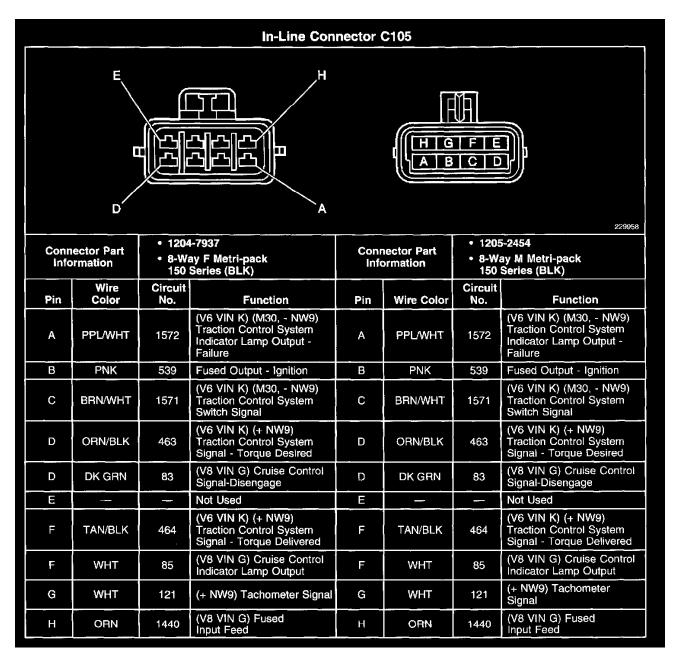
In-Line Connector C105
